## DAILY PRODUCTION & QUALITY CONTROL REPORT

Project No./Contract No.	Project Title / Location	Day of Report	Report No.
6389	BRC Eastside Common Areas Soils Remediation	07-Aug-08	42

### DAILY PHOTO LOG

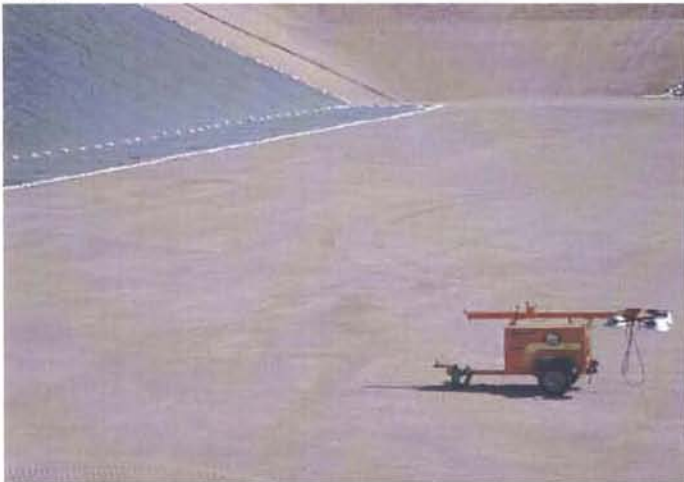
Photo 1

CAMU, Phase 1 Light plant for night work on floor.

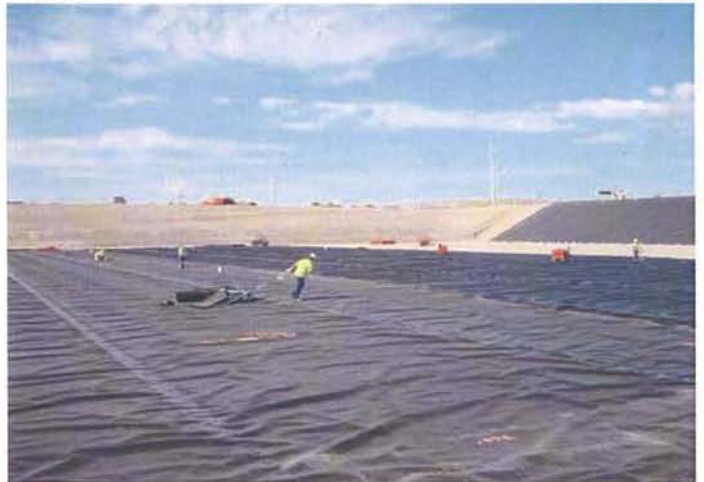
Photo 2

CAMU, Phase 1, Liner Crew performing housekeeping.

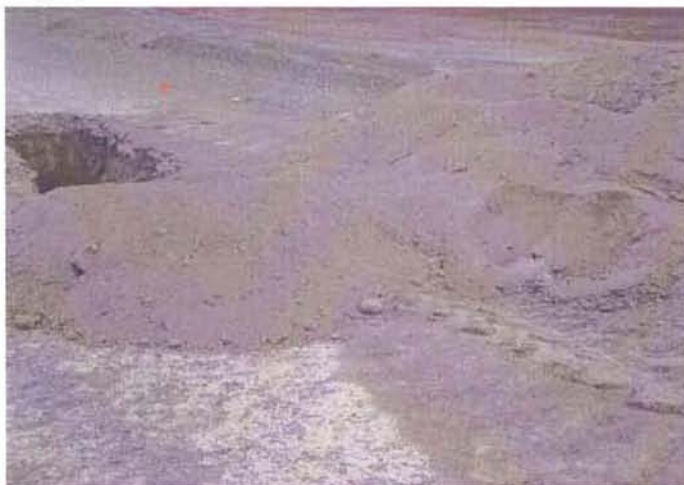
Photo 3

Northeast detention basin. Potholing excavations begun.

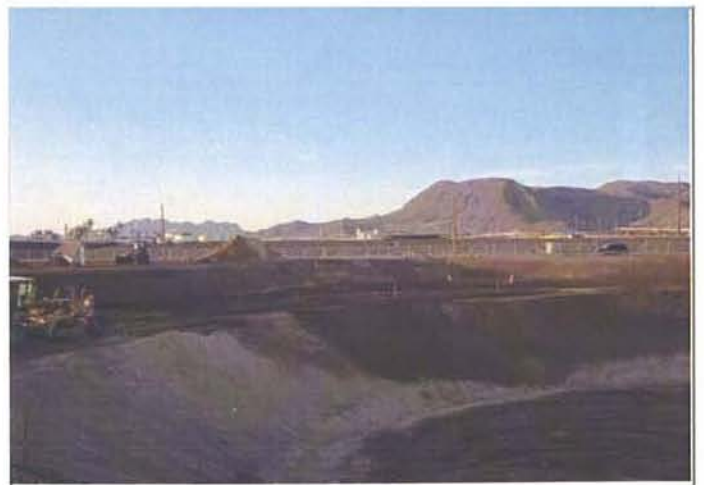
Photo 4

CAMU, Phase 2, Shaping southern slope.
