## DAILY PRODUCTION & QUALITY CONTROL REPORT

Project No./Contract No.	Project Title / Location	Day of Report	Report No.
6389	<b>BRC Eastside Common Areas Soils Remediation</b>	19-Aug-08	<b>52</b>

### DAILY PHOTO LOG

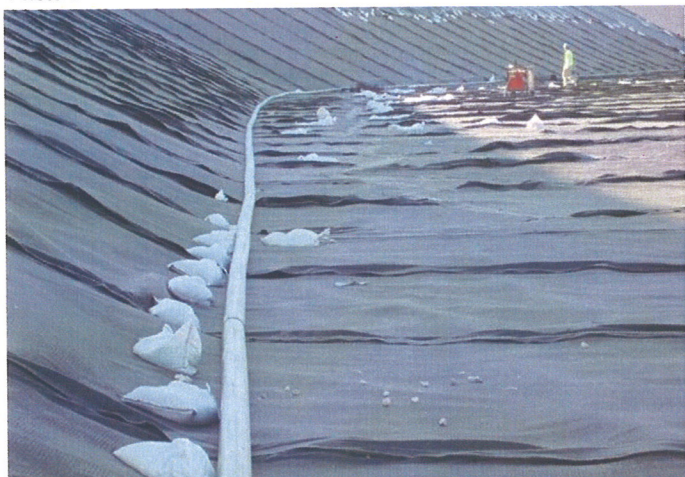
Photo 1

CAMU, Phase 1, 4" HDPE pipe being installed for LCERS system..

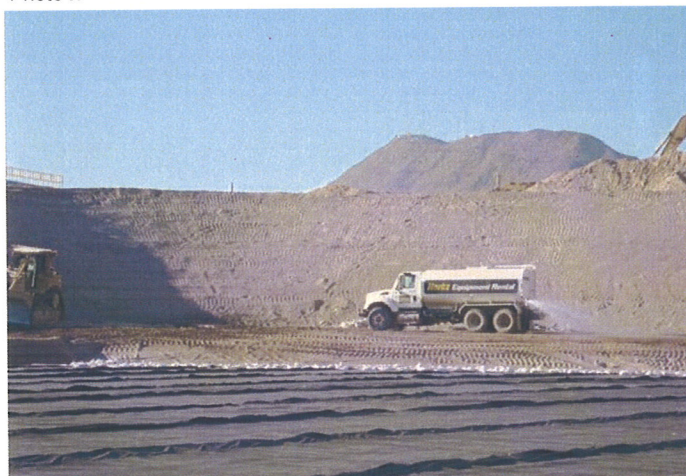
Photo 2

CAMU: Phase 1 Dust control for beginning of OPS Layer placement.  
Bottom of Ramp.

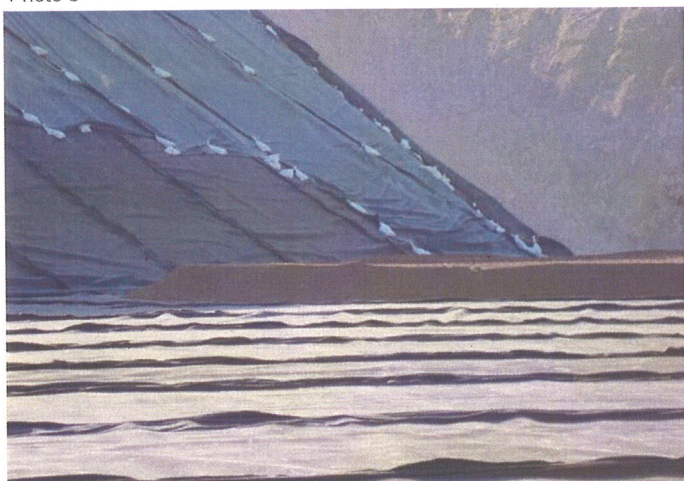
Photo 3

CAMU: Phase 1 Operations layer being placed.

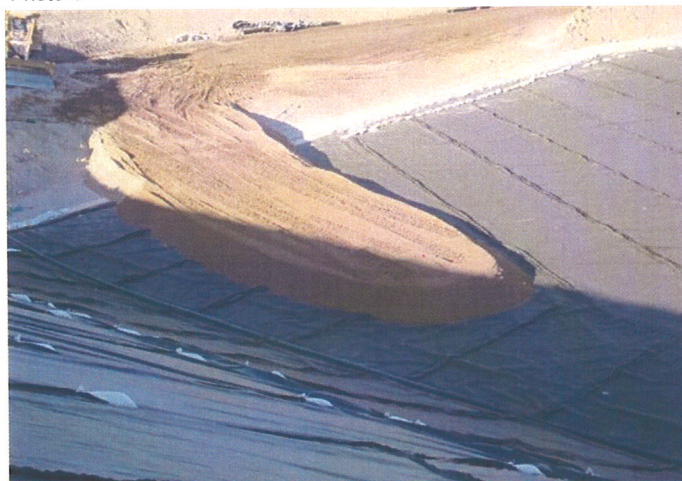
Photo 4

Phase 1 Operations layer placed on liner.
