DAILY PRODUCTION & QUALITY CONTROL REPORT

Project No./Contract No.	Project Title / Location	Day of Report	Report No.
6389	BRC Eastside Common Areas Soils Remediation	05-Dec-08	149

Eastside Mixing and Drying Activity:

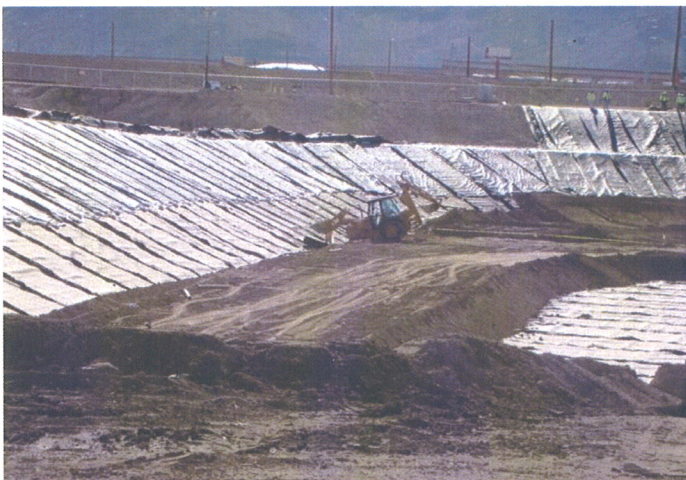
Photo 1

CAMU: Phase II East slope, toe drain rock installation.

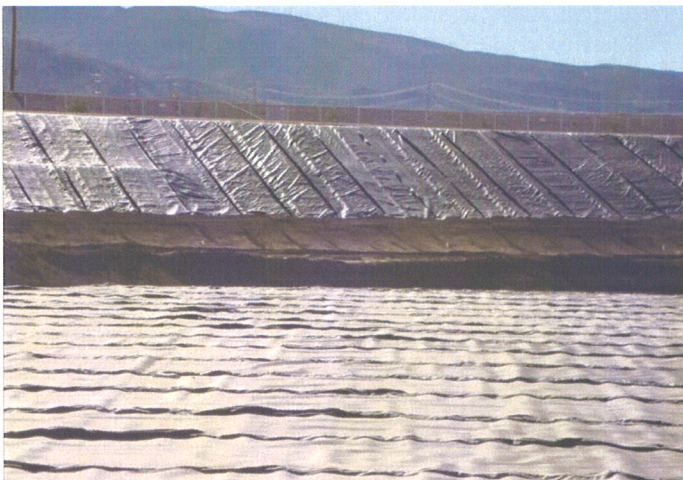
Photo 2

CAMU: Phase II, Operations layer placed on slope.

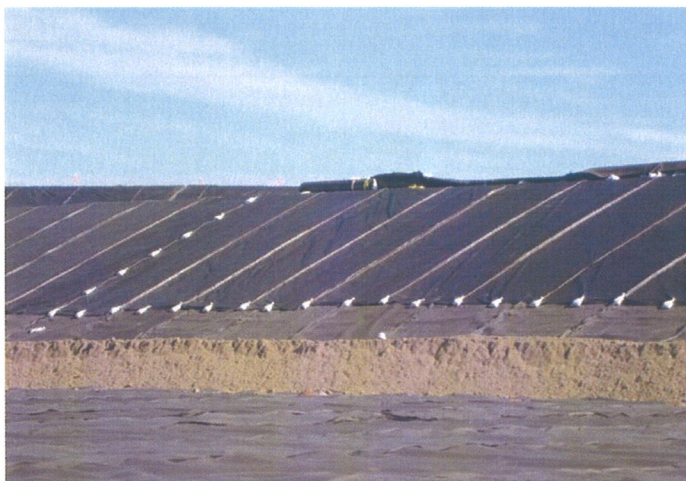
Photo 3

CAMU: Phase II East slope operations layer road for toe drain installation.

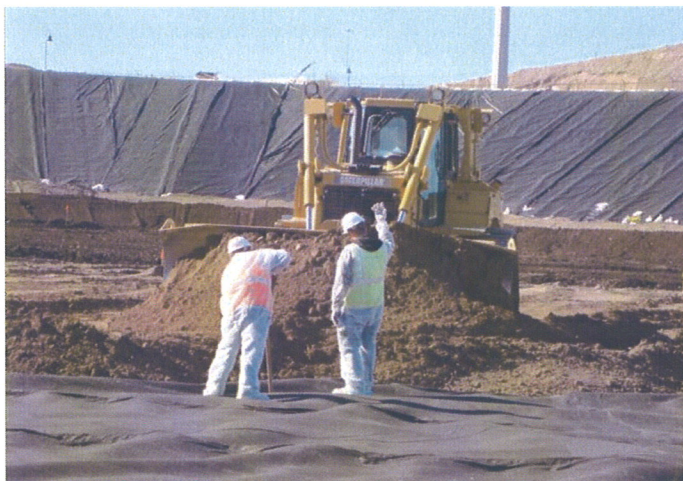
Photo 4

CAMU: Phase II, Operations layer placement monitored by Entact, Geosyntec and Weston.
