## DAILY PRODUCTION & QUALITY CONTROL REPORT

Project No./Contract No.	Project Title / Location	Day of Report	Report No.
6389	BRC Eastside Common Areas Soils Remediation	08-Dec-08	152

# Basic Remediation Company

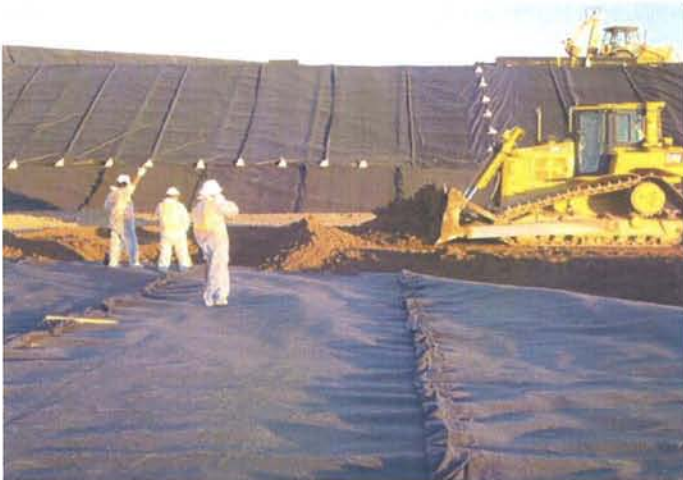
Photo 1

CAMU: Phase II, operations layer placement being monitored by Entact, Geosyntec, Weston.

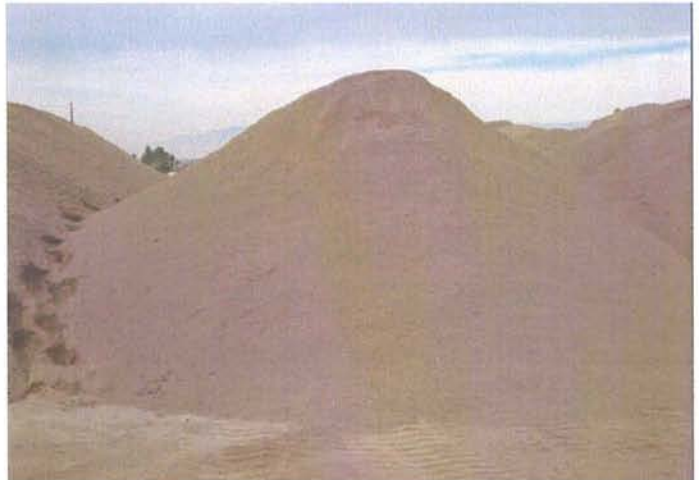
Photo 2

Eastside: WST-1, Powerscreened 1" minus, soils. Inspected by Weston.

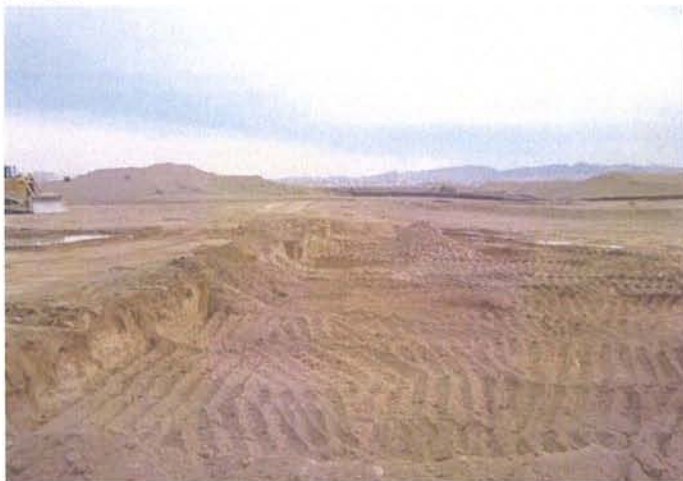
Photo 3

Eastside: WST-1

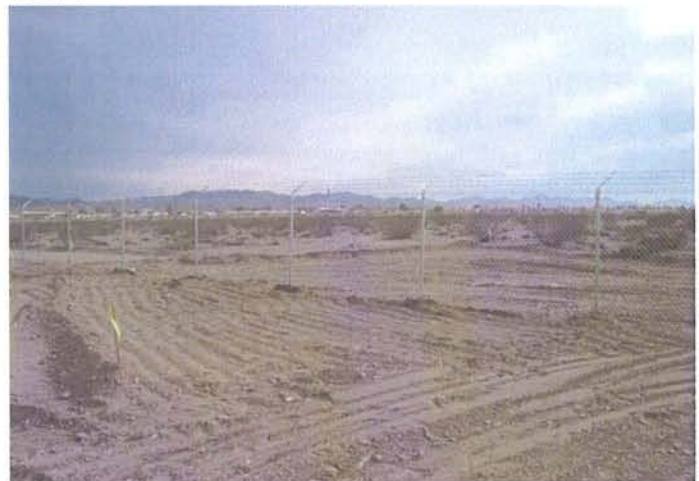
Photo 4

Eastside: Scraping of 4B.
