DAILY PRODUCTION & QUALITY CONTROL REPORT

Project No./Contract No.	Project Title / Location	Day of Report	Report No.
6389	BRC Eastside Common Areas Soils Remediation	21-Apr-09	282

DAILY PHOTO LOG

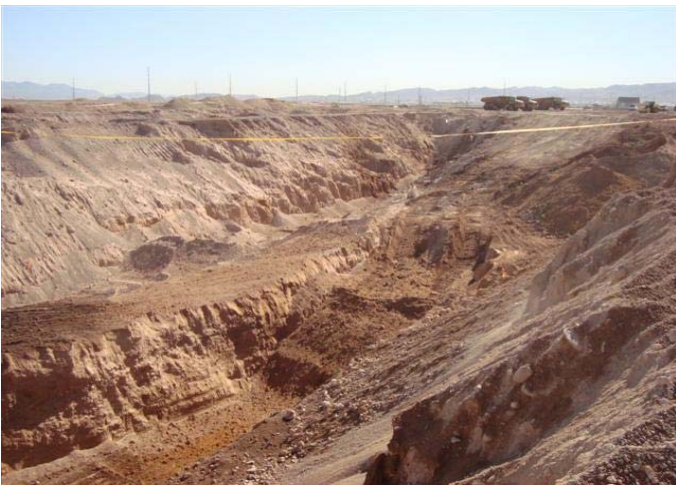
Photo 1

Inspections: CAMU: Weston monitored sump access.
SW-1, Silt trench inspected. Additional cleanup completed to the east.
Inspected by MGA and Weston. Cleared for backfill up to stakes beyond Phase IIIB boundary.

CAMU: SW-1 Slit trench.

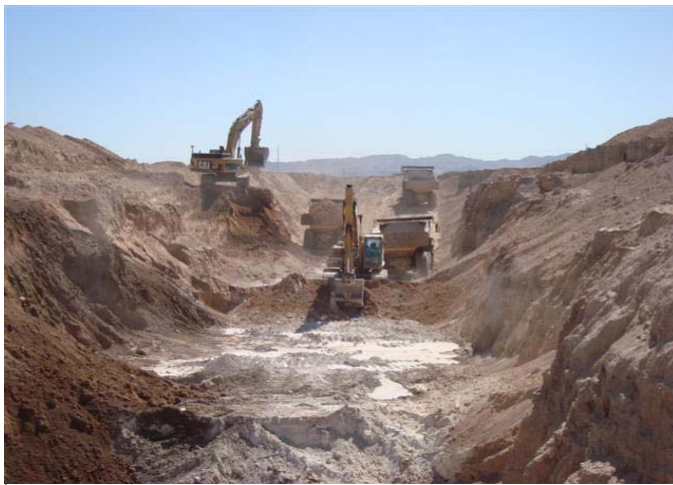
Photo 2

CAMU: NW-1, Slit trench.

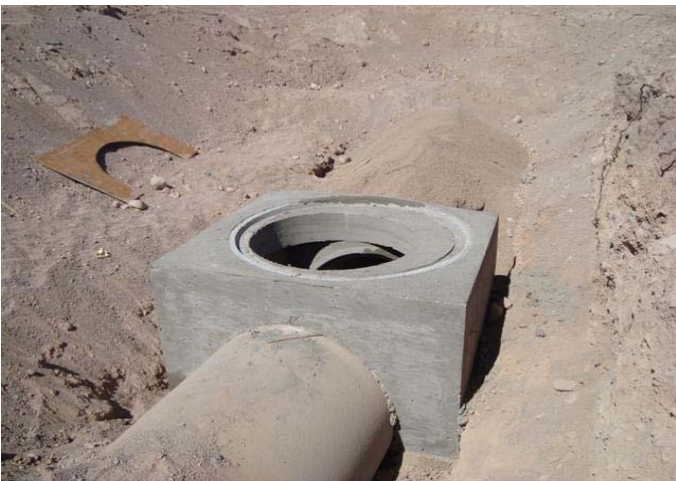
Photo 3

CAMU: Manhole # 4, Storm drainage system.

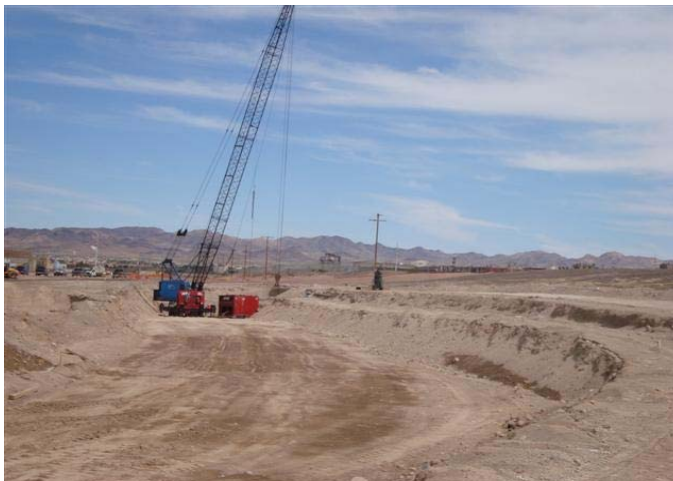
Photo 4

CAMU: Sheet Piling all removed.
