Project No./Contract No.	Project Title / Location	Day of Report	Report No.
6389	BRC Eastside Common Areas Soils Remediation	24-Apr-09	285

DAILY PRODUCTION & QUALITY CONTROL REPORT							
Project No./Contract No.		Project Title / Location			Day of Report		Report No.
6389		BRC Eastside Common Areas Soils Remediation			24-Apr-09		285
Geocomposite	Agro	0	rolls	For CAMU, On site	2373		
Geomembrane	Agro	0	rolls	For CAMU, On site	514		
WORK COMPLETED							
Description of Work Executed Today							
Eastside Mixing and Drying Activity:							
Day Shift:

DAILY PHOTO LOG

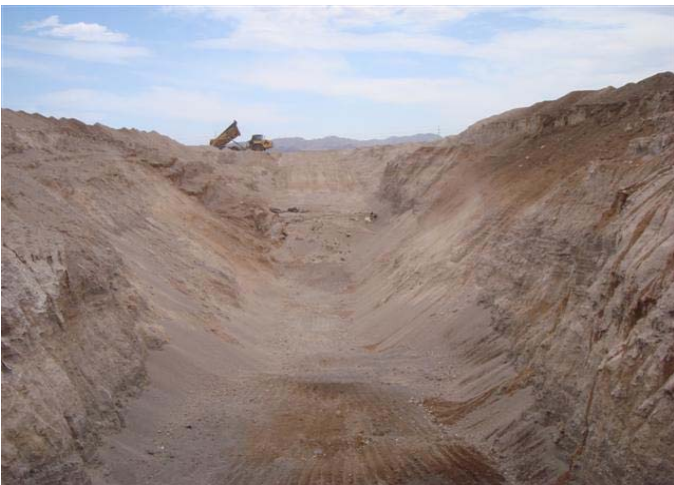
Photo 1

CAMU: NW-1, Slit trench.

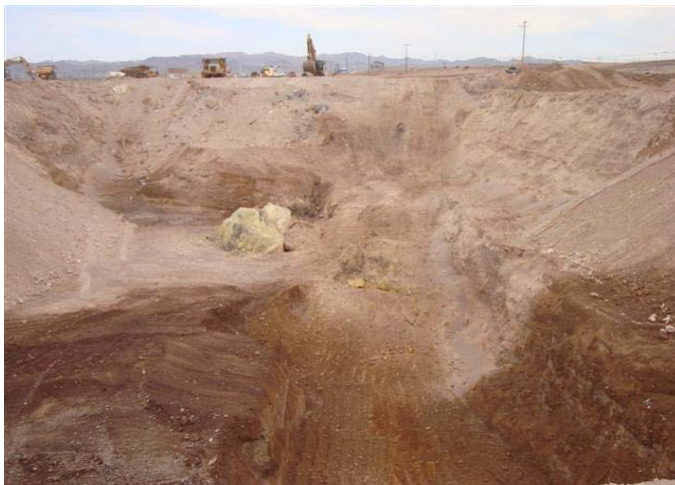
Photo 2

CAMU: SW-1, Slit trench.

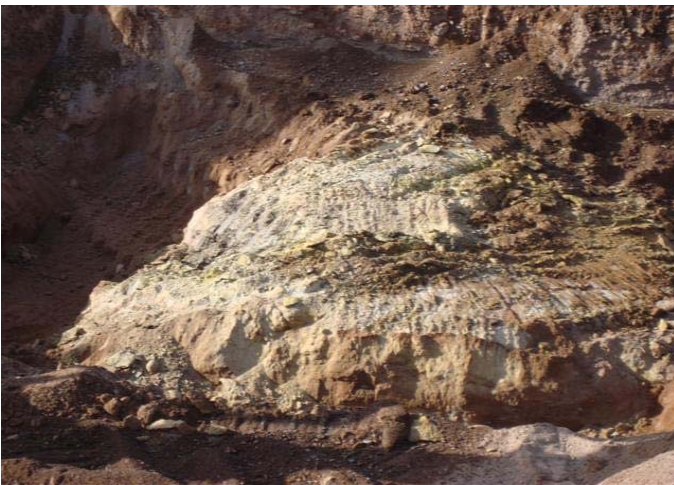
Photo 3

CAMU: SW-1, Slit trench.

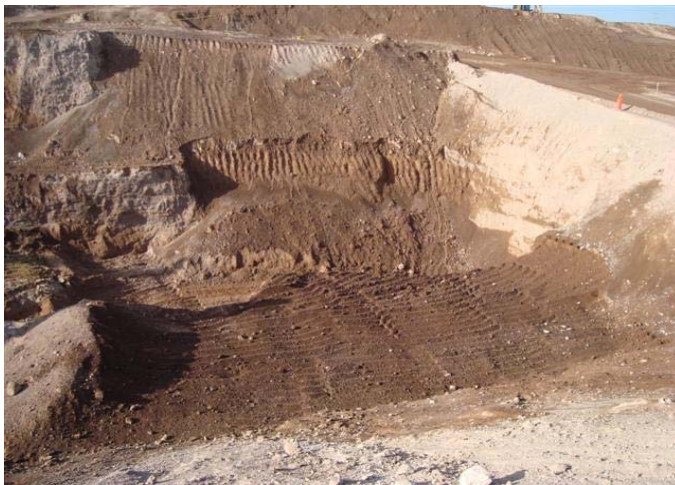
Photo 4

CAMU: SW-1, Slit trench.
