Project No./Contract No.	Project Title / Location	Day of Report	Report No.
6389	BRC Eastside Common Areas Soils Remediation	31-Dec-09	529

DAILY PRODUCTION & QUALITY CONTROL REPORT

Basic Remediation Company

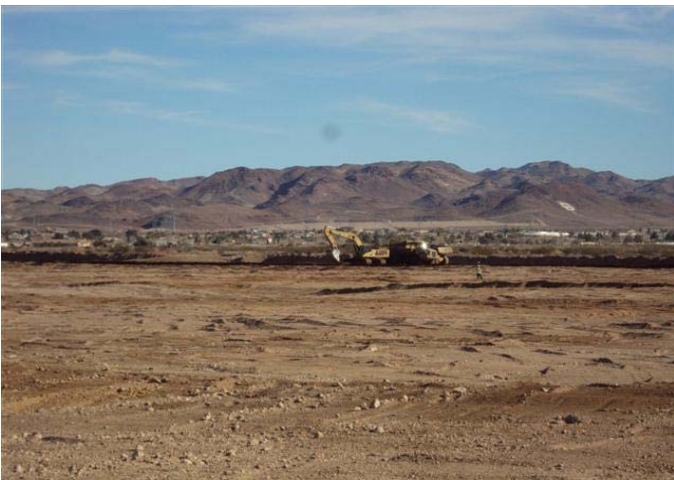
Photo 1

Eastside: HP Ponds

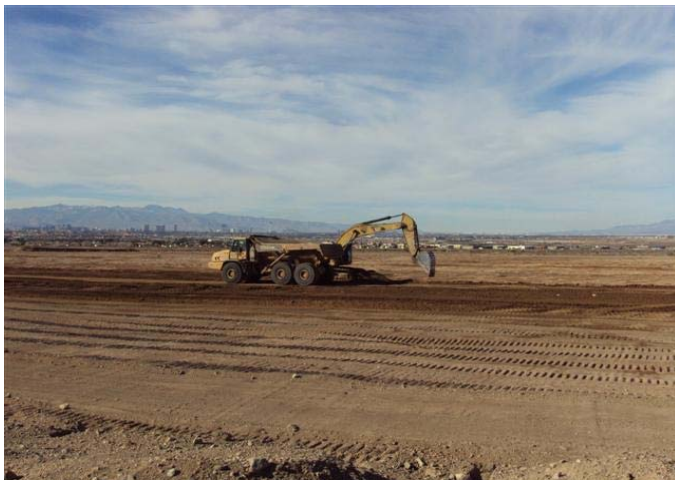
Photo 2

Eastside: HP Ponds.

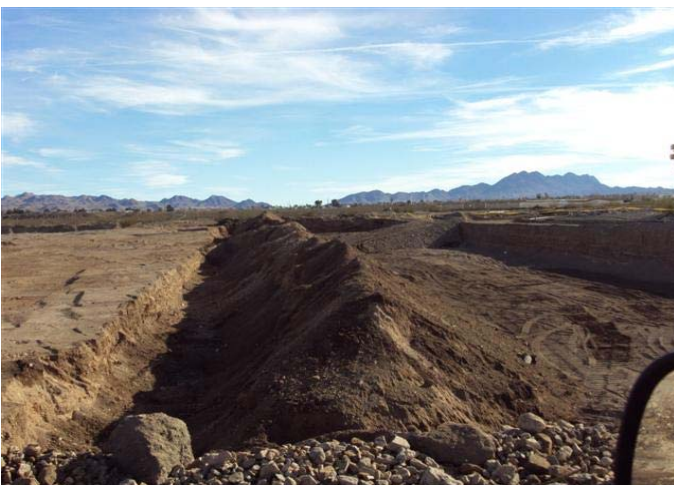
Photo 3

Eastside: Beta ditch. East end

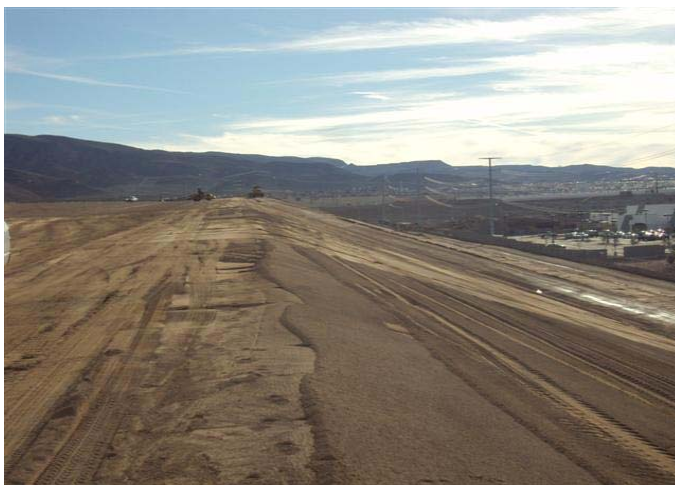
Photo 4

CAMU: Phase I, Phase II, Phase IIIB, West slope.
