DAILY PRODUCTION & QUALITY CONTROL REPORT

Project No./Contract No.	Project Title / Location	Day of Report	Report No.
6389	BRC Eastside Common Areas Soils Remediation	02-Aug-08	38

DAILY PHOTO LOG

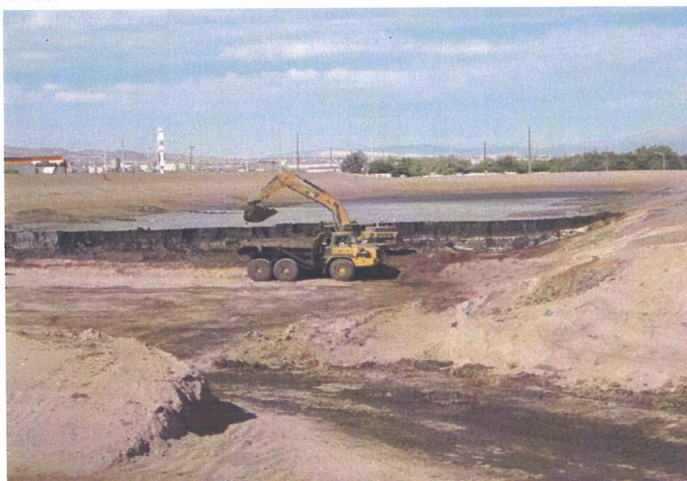
Photo 1

Eastside, SW-4 load out.

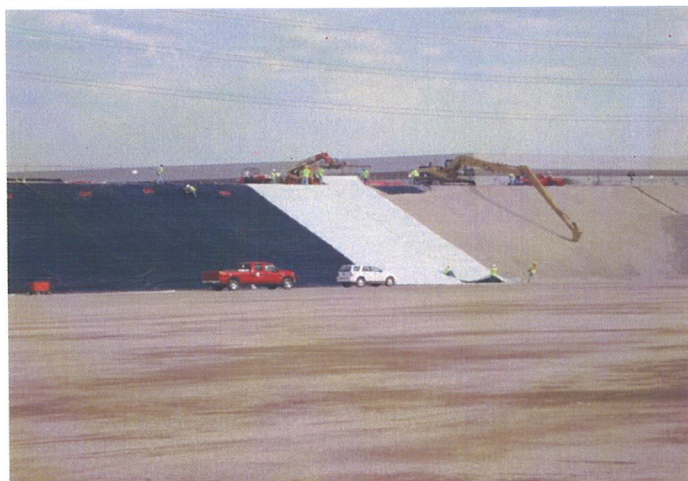
Photo 2

Inspected and documented, Phase 1 Liner Installation, on west slope..

CAMU, Phase 1, Liner Crew Deploying liner on West Slope.

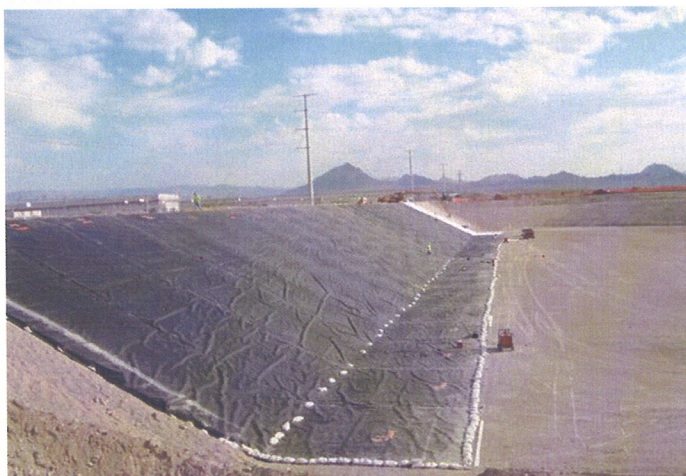
Photo 3

CAMU, Phase 1 Liner deployed Saturday, end of day..

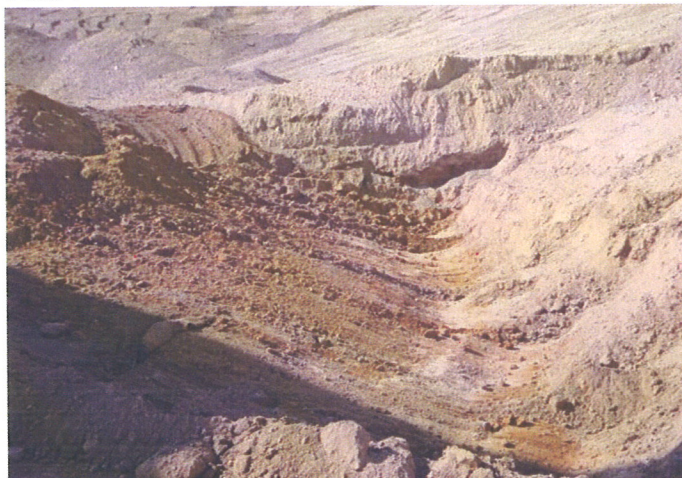
Photo 4

Eastside, SW-8, Remediation below liner. Two areas remain discolored after 5' excavation below liner.

Eastside, SW-8 discolored soils excavated 5' below liner. Still showing discoloration.
