DAILY PRODUCTION & QUALITY CONTROL REPORT

Project No./Contract No.	Project Title / Location	Day of Report	Report No.
6389	BRC Eastside Common Areas Soils Remediation	04-Sep-08	67

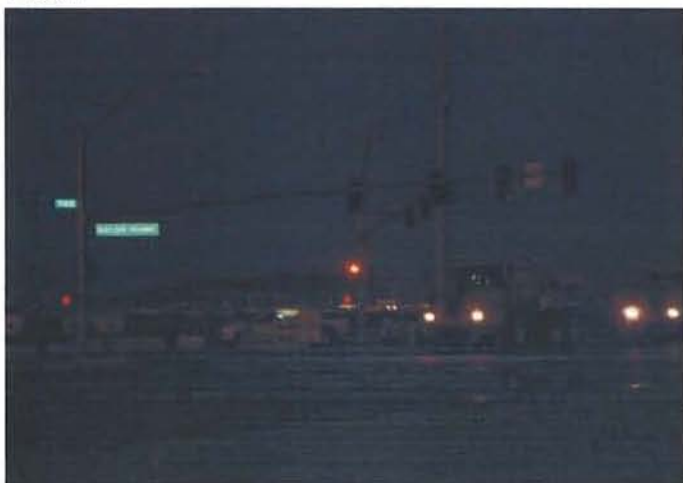
Photo 1

Haul Trucks Dry Run across Boulder highway with (3) 40 ton dump trucks was accomplished beginning at 7pm.. City of Henderson, Traffic controller on hand to adjust lights to simulate time needed for trucks to get thru intersection safely.

Haul trucks dry run across Boulder Highway.

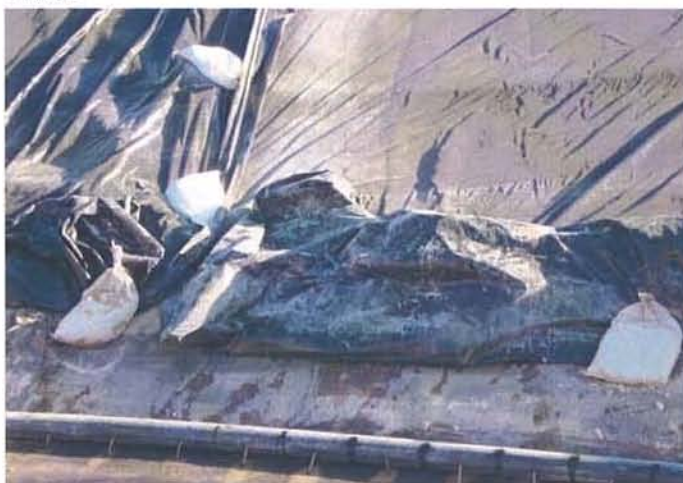
Photo 2

Other: CAMU, Phase 1 LCRS inspection, Dan Street, Geosyntec, Dick Laubinger, Weston inspected LCRS pipe flushing, Entact washing pipe and cleaning out all holes with pointed objects. Approx 40' remaining to be inspected. 9-5-08.

CAMU: Inspected LCRS 4" Pipe flushing going well, approx. 40' left for inspection tomorrow.

CAMU: Phase 1 LCRS pipe cleanout and flushing.

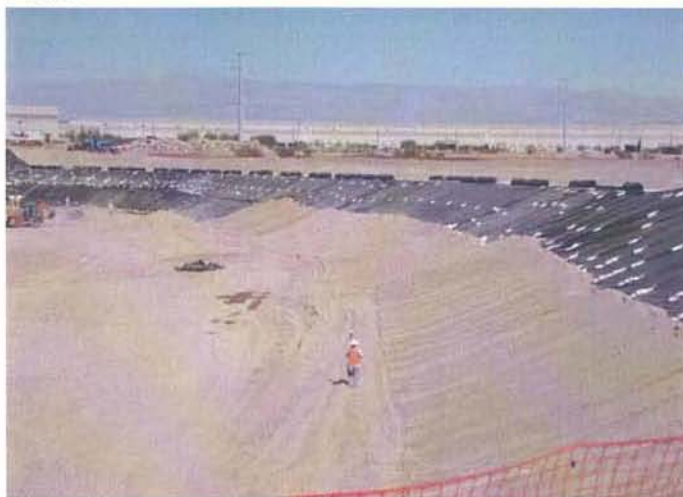
Photo 3

Inspected 12' capped haul roads for degradation. All areas ok.
Inspected shoveling/sweeping cleanup activity at Northeast slope floor area and toe drain. approved floor for ops placement closer to sump.
Inspected sump again after flushing of 4" pipe. Approved. Approx. 40' of pipe left to inspect.

CAMU: Phase 1 ops layer on Northeast slope.

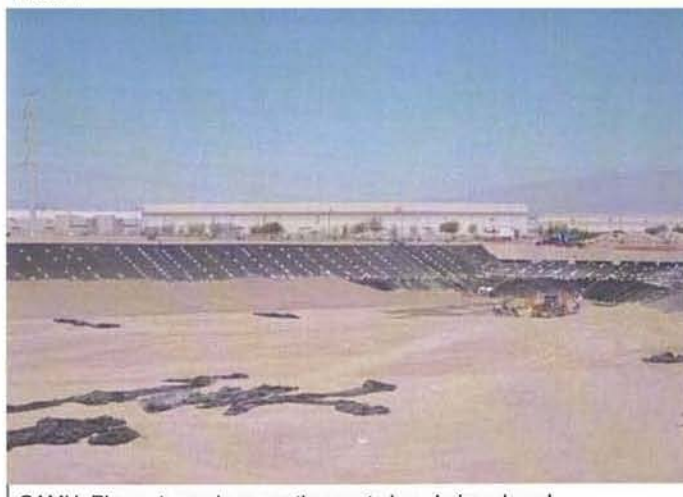
Photo 4

CAMU, Phase 1, ops layer on the west slope being placed..
