DAILY PRODUCTION & QUALITY CONTROL REPORT

Project No./Contract No.	Project Title / Location	Day of Report	Report No.
6389	BRC Eastside Common Areas Soils Remediation	13-Sep-08	75

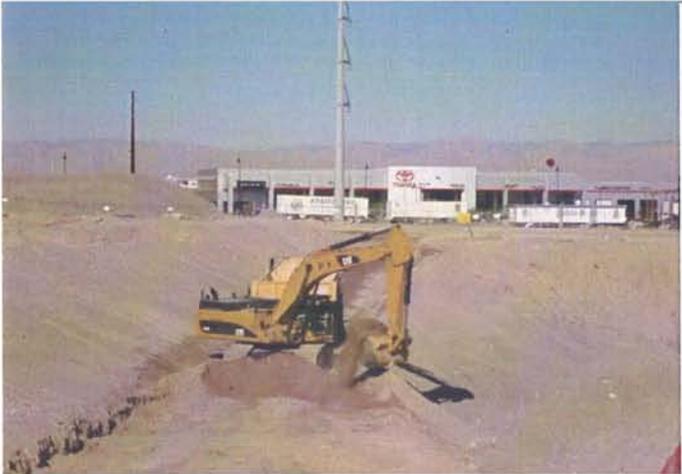
Photo 1

CAMU, Phase 1 scraping ramp of potentially contaminated soils.

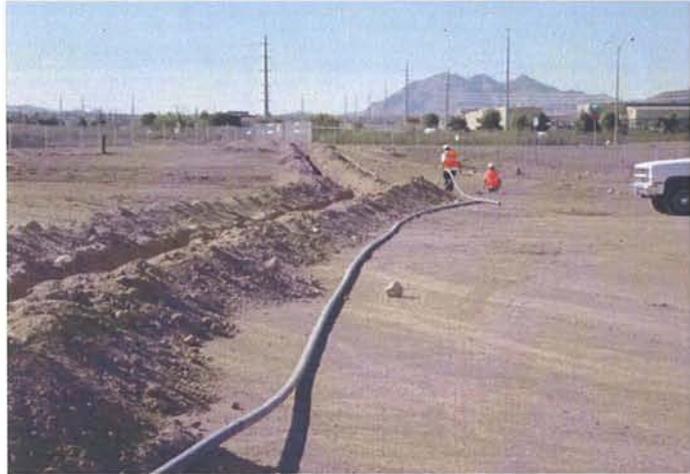
Photo 2

Eastside, Installing electrical conduit. To project trailers.

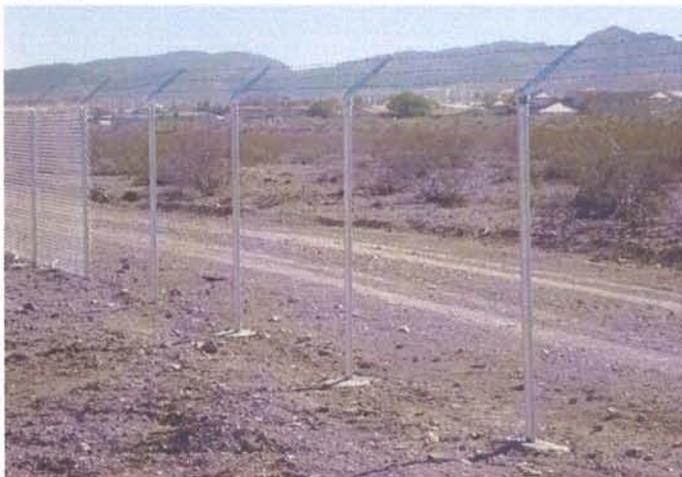
Photo 3

Eastside: Fence stolen Friday night 9-12-08. Southeast side.

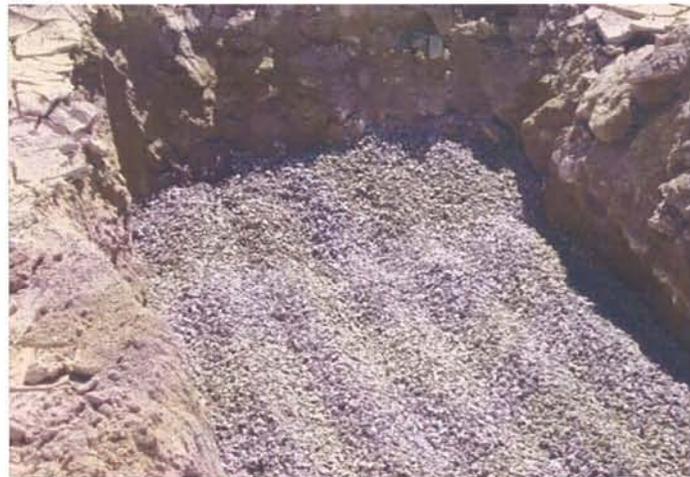
Photo 4

CAMU: Phase 2, potholes. Silt and sediment removed backfilled with rock above water level.
