DAILY PRODUCTION & QUALITY CONTROL REPORT

Project No./Contract No.	Project Title / Location	Day of Report	Report No.
6389	BRC Eastside Common Areas Soils Remediation	09-Oct-08	97

DAILY PHOTO LOG

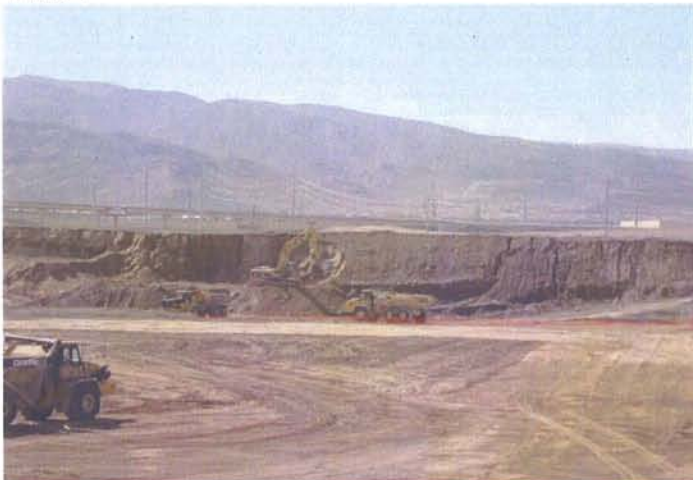
Photo 1

CAMU: Phase 1 western ditch soils being loaded.

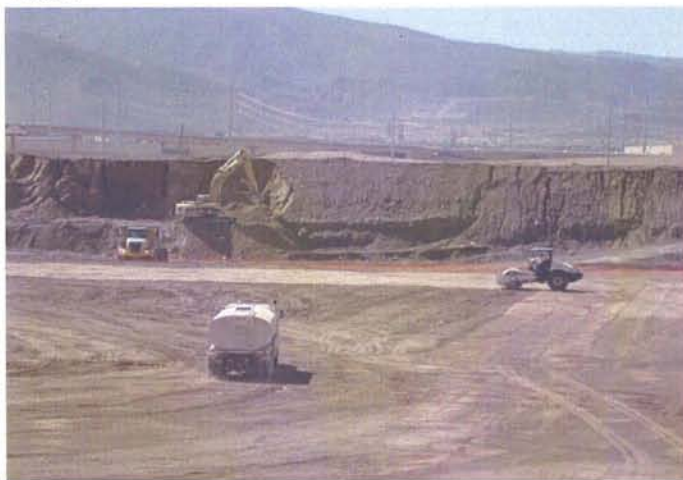
Photo 2

CAMU: Phase 1 western ditch soils being loaded and rolled.

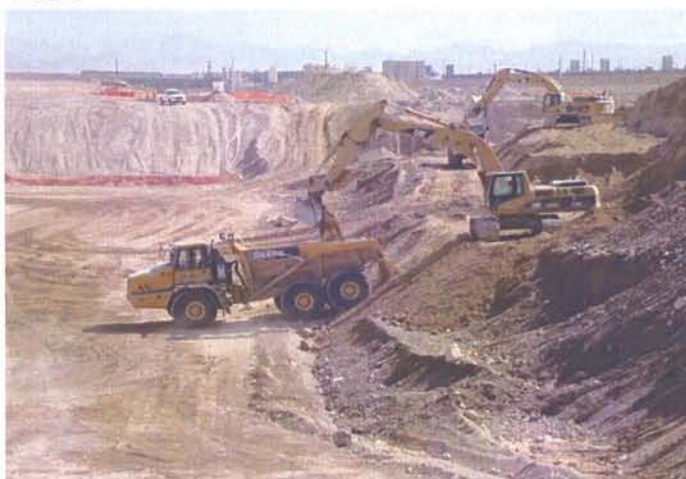
Photo 3

CAMU: Phase 1 Western ditch soils being loaded.

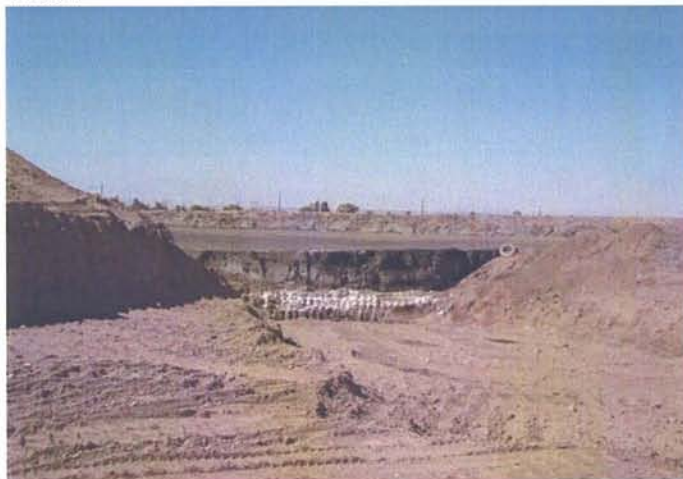
Photo 4

Eastside: SC-1 Ramp.
