DAILY PRODUCTION & QUALITY CONTROL REPORT

Project No./Contract No.	Project Title / Location	Day of Report	Report No.
6389	BRC Eastside Common Areas Soils Remediation	18-Oct-08	105

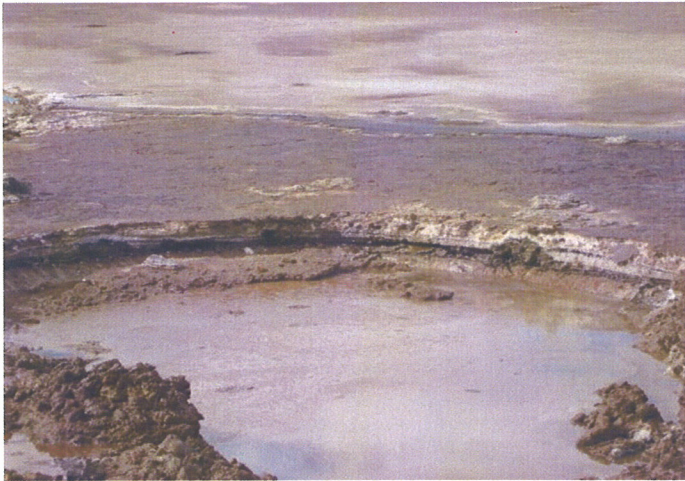
Photo 1

Eastside: SW-12. Crust over water.

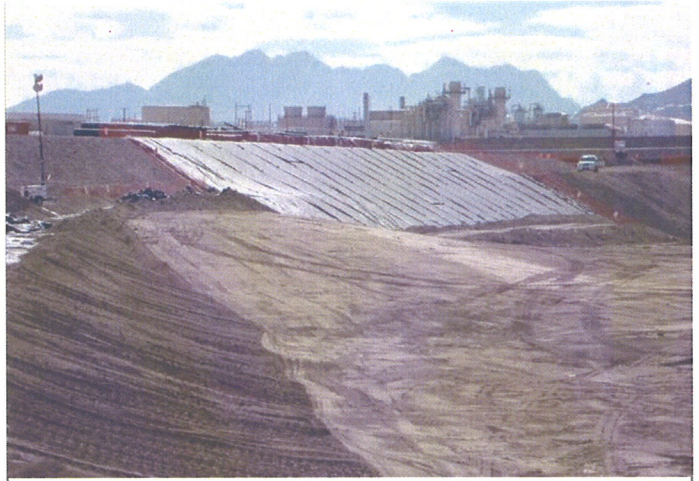
Photo 2

CAMU: Phase 1. Ramp.

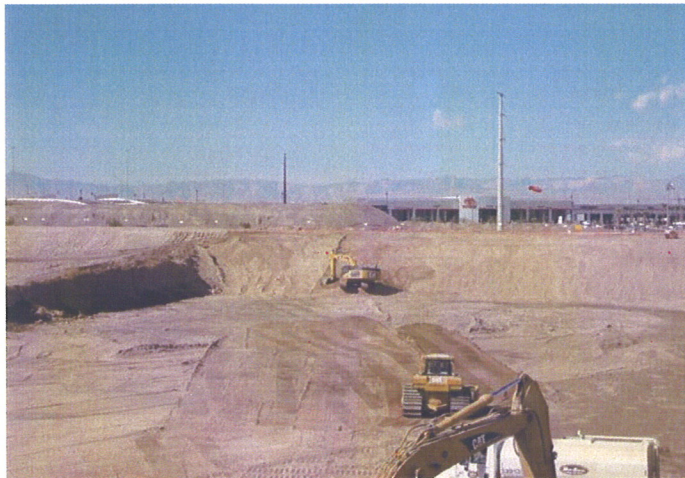
Photo 3

CAMU: Phase 2. Western ditch grading the floor.

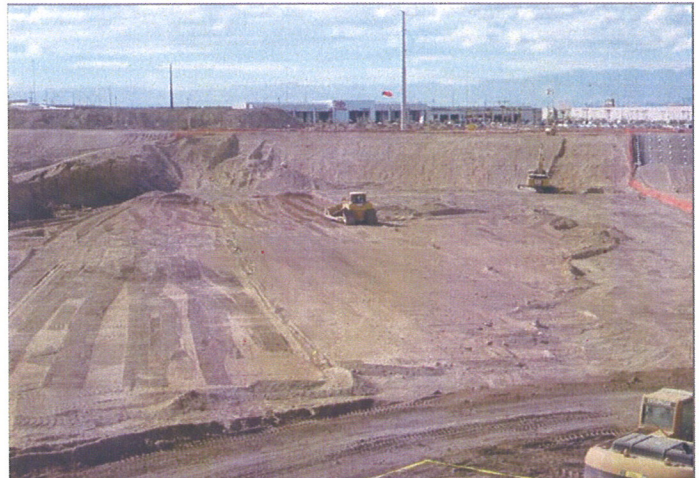
Photo 4

CAMU: Phase 2. Western ditch grading floor.
