Project No./Contract No.	Project Title / Location	Day of Report	Report No.
6389	BRC Eastside Common Areas Soils Remediation	19-Oct-09	460

DAILY PRODUCTION & QUALITY CONTROL REPORT

DAILY PHOTO LOG

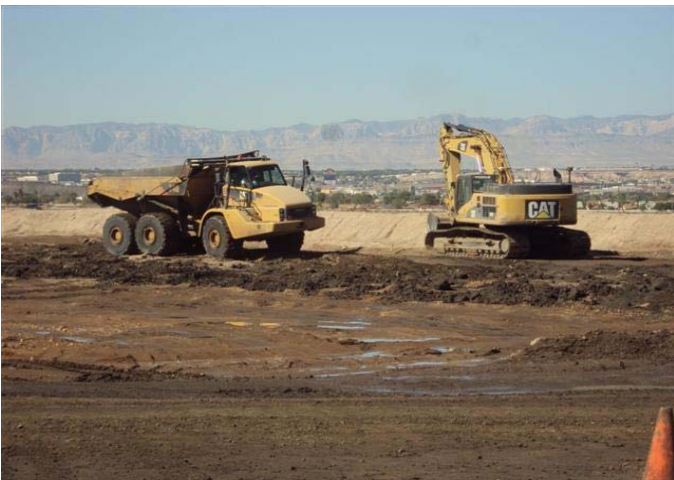
Photo 1

Eastside: Dry ponds.

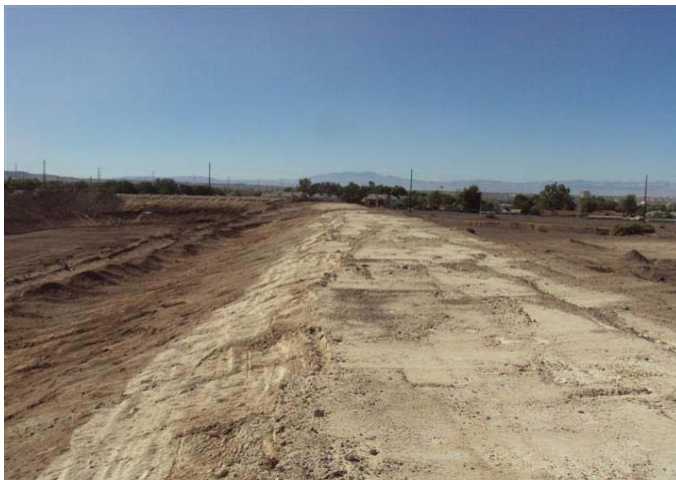
Photo 2

Eastside: SW-7.

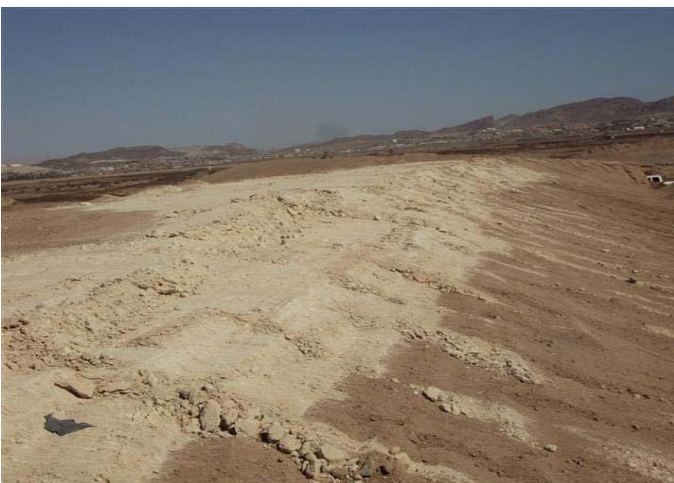
Photo 3

Eastside: SW-7.

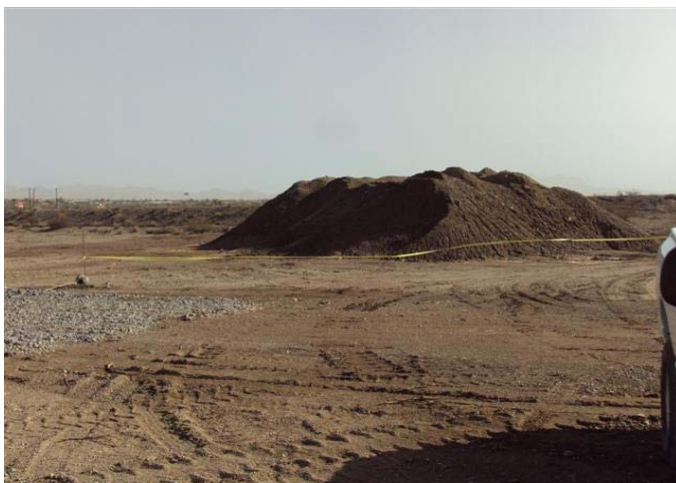
Photo 4

Galleria Scrape.
