DAILY PRODUCTION & QUALITY CONTROL REPORT

Project No./Contract No.	Project Title / Location	Day of Report	Report No.
6389	BRC Eastside Common Areas Soils Remediation	31-Aug-08	63

DAILY PHOTO LOG

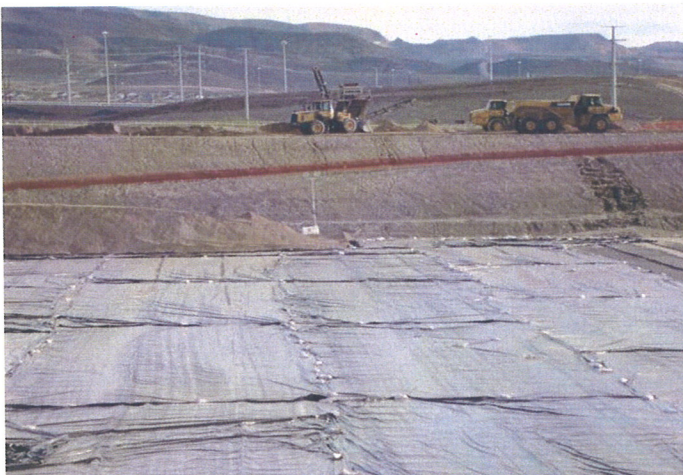
Photo 1

CAMU, Phase 1, operations layer placement and plastic temporary coverage.

Operations layer placement on liner. Placed until 7:30 pm. Inspected plastic on floor had Entact maintain as needed.

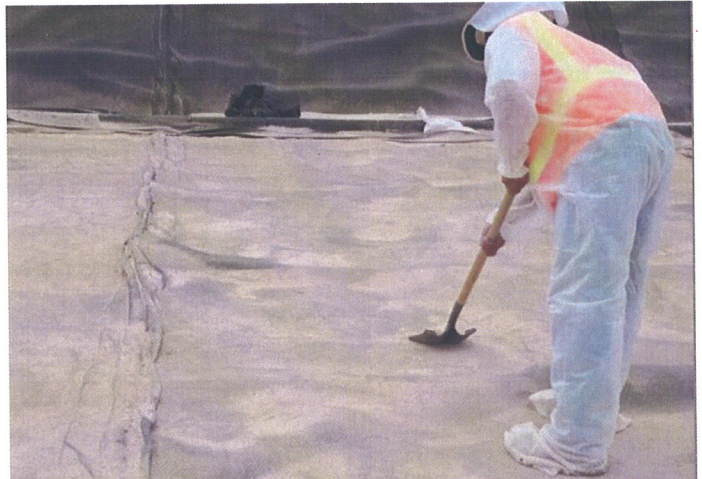
Photo 2

CAMU: Phase 1 typical shoveling of silt runoff cleanup.

Inspected shoveling cleanup activity at southwest corner, needs a little more work.

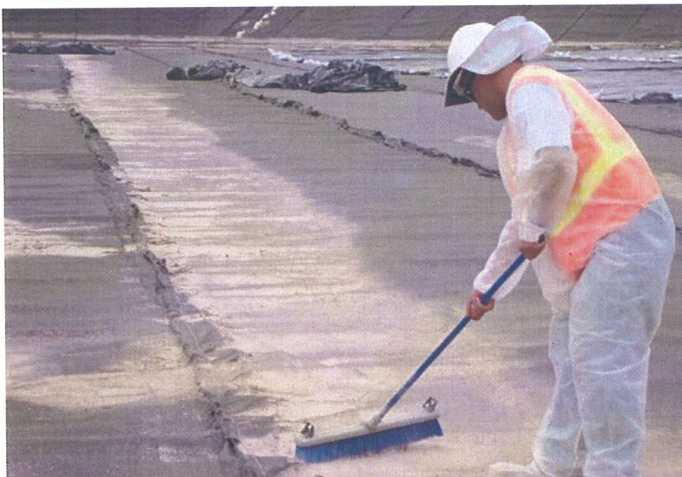
Photo 3

CAMU: Phase 1, typical sweeping of silt runoff cleanup..

More clean off of silt activity today. Phase 1 floor.

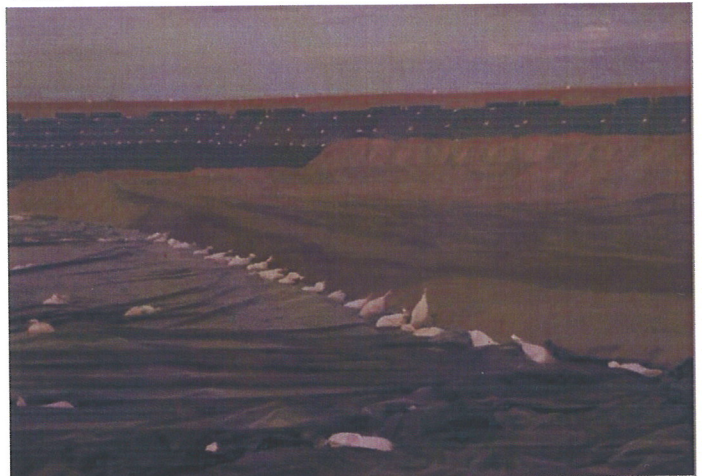
Photo 4

CAMU, Phase 1, Operations layer showing East slope coverage..
