## DAILY PRODUCTION & QUALITY CONTROL REPORT

Project No./Contract No.	Project Title / Location	Day of Report	Report No.
6389	<b>BRC Eastside Common Areas Soils Remediation</b>	04-Sep-08	<b>67</b>

### DAILY PHOTO LOG

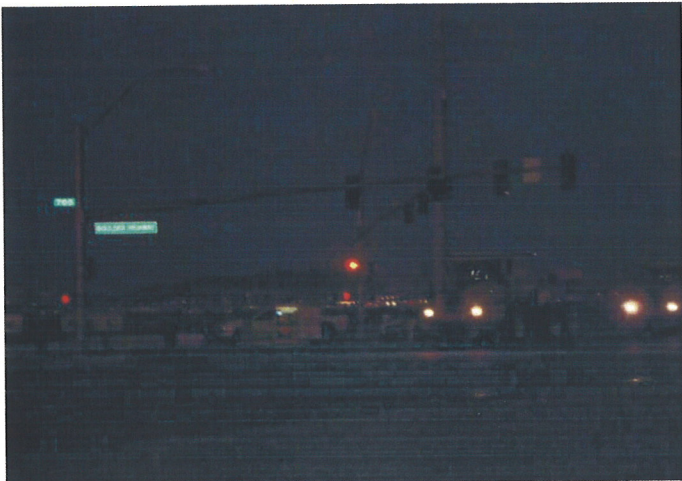
Photo 1

Haul trucks dry run across Boulder Highway.

Haul Trucks Dry Run across Boulder highway with (3) 40 ton dump trucks was accomplished beginning at 7pm.. City of Henderson. Traffic controller on hand to adjust lights to simulate time needed for trucks to get thru intersection safely.

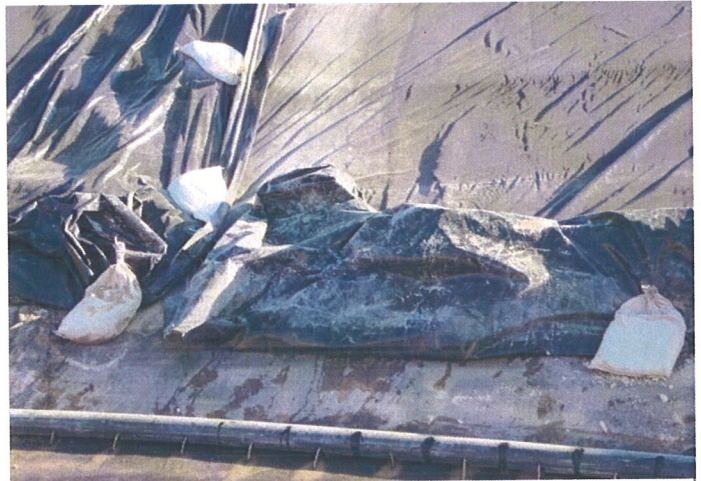
Photo 2

**Other:** CAMU, Phase 1 LCRS inspection, Dan Street, Geosyntec, Dick Laubinger, Weston inspected LCRS pipe flushing. Entact washing pipe and cleaning out all holes with pointed objects. Approx 40' remaining to be inspected. 9-5-08.

Inspected sump again after flushing of 4" pipe, Approved. Approx. 40' of pipe left to inspect.

CAMU: Inspected LCRS 4" Pipe flushing going well, approx. 40' left for inspection tomorrow.

CAMU: Phase 1 LCRS pipe cleanout and flushing.

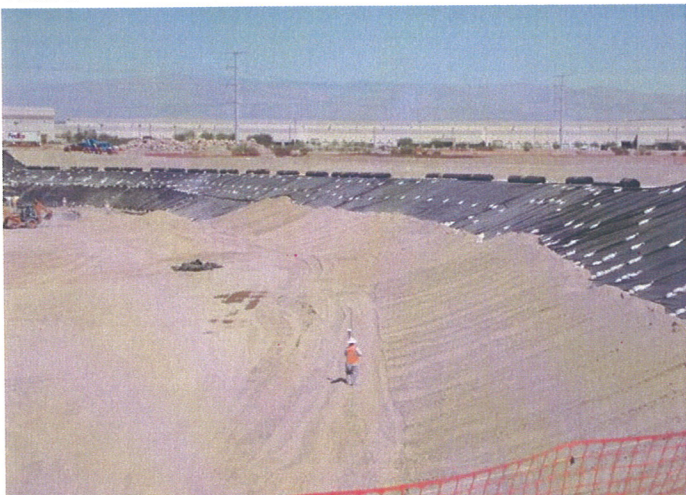
Photo 3

Inspected shoveling/sweeping cleanup activitiy at Northeast slope floor area and toe drain. approved floor for ops placement closer to sump.

CAMU: Phase 1 ops layer on Northeast slope.

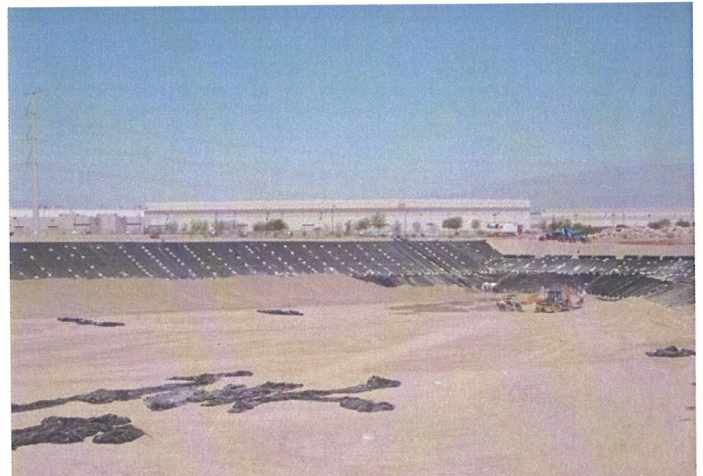
Photo 4

CAMU, Phase 1, ops layer on the west slope being placed..
