DAILY PRODUCTION & QUALITY CONTROL REPORT

Project No./Contract No.	Project Title / Location	Day of Report	Report No.
6389	BRC Eastside Common Areas Soils Remediation	15-Sep-08	76

DAILY PHOTO LOG

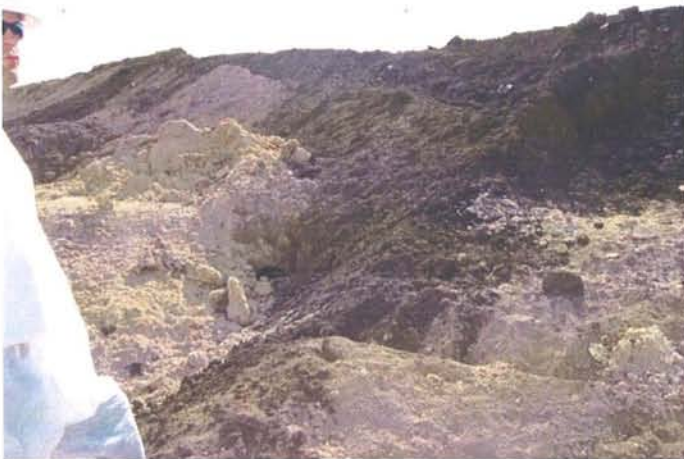
Photo 1

Eastside: Soils chosen for one pad.

Two test pads constructed on eastside with contaminated material, 50'X50', 12" thick.

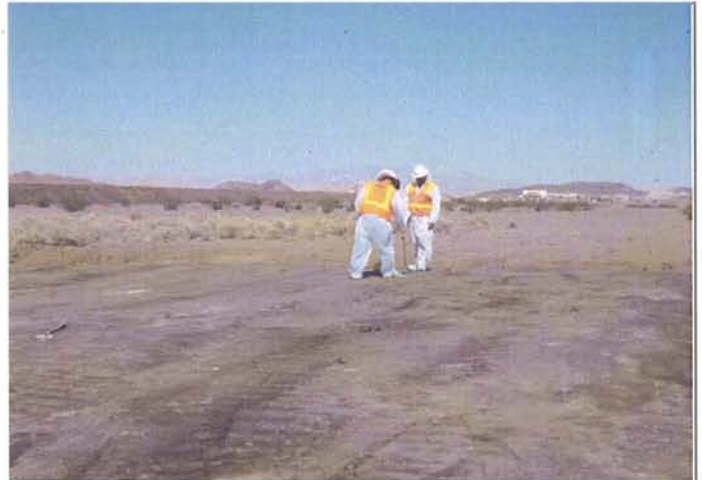
Photo 2

Eastside, Geosyntec performing compaction testing on test pads..

Observed two test pads built on eastside. Performed compaction testing and observed loaded haul truck on pads for rutting. Met spec.

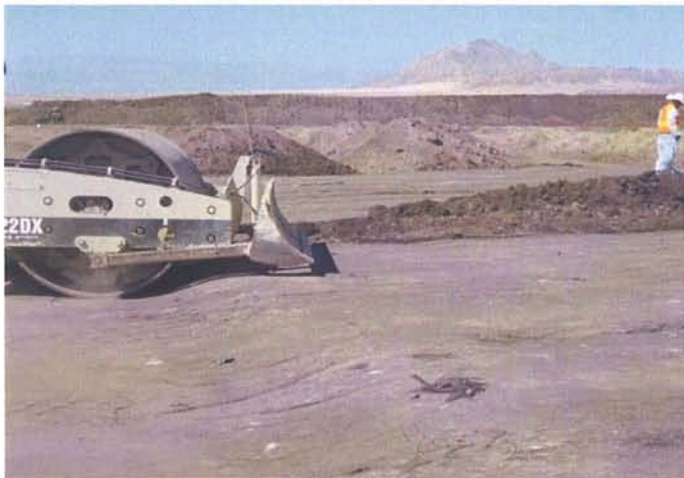
Photo 3

Eastside: Roller used to provide compaction.

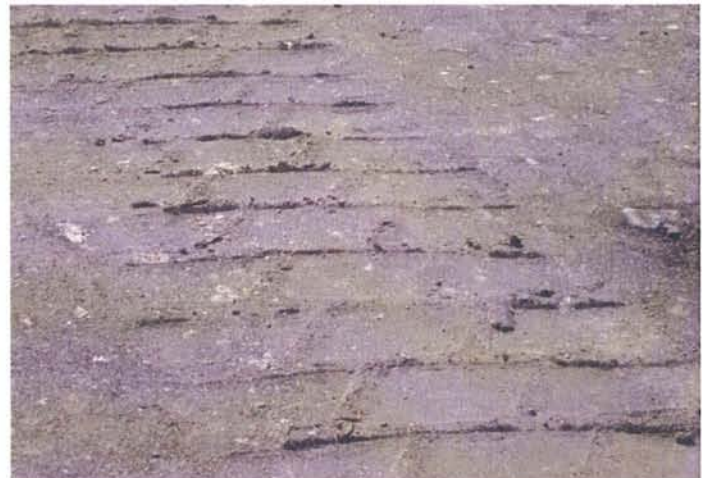
Photo 4

Eastside: Rutting was minor after 40 ton loaded dump truck backed on test pad.
