## DAILY PRODUCTION & QUALITY CONTROL REPORT

| Project No. Contract No. | Project Title / Location | Day of Report | Report No. |
|---|---|---|---|
| 6389 | BRC Eastside Common Areas Soils Remediation | 10-Feb-09 | 212 |

### DAILY PHOTO LOG

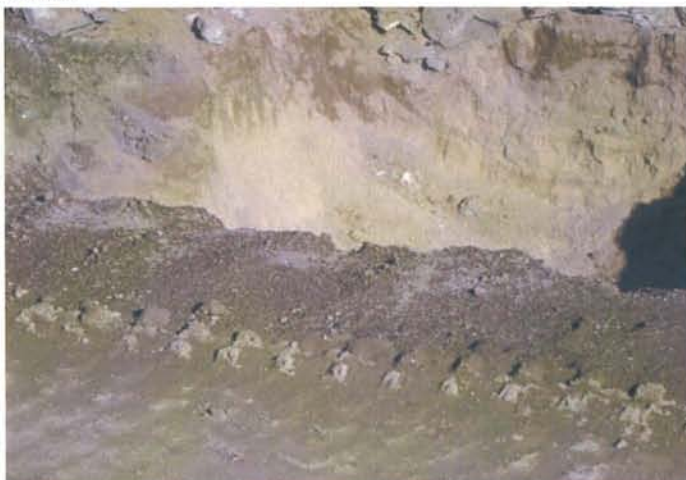
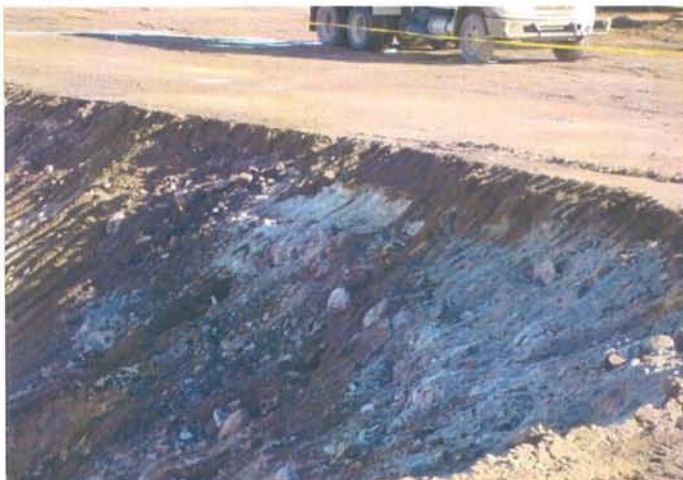
Photo 1

Slit Trench NW-1, excavation, observations: white material, small rubble continues, encountering clean soils above design grade on floor. Inspected and advised contractor to discontinue removing clean and move over to waste. Inspected by Devin Gordon, McGinley, Dick Laubinger, Weston.

CAMU: Slit trench, NW-1.

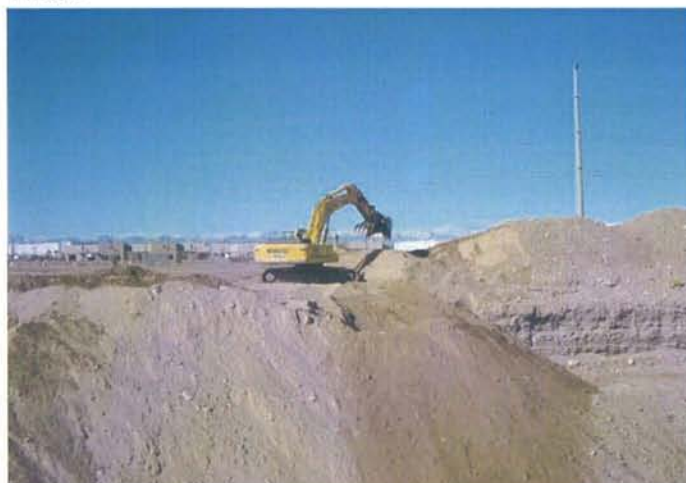
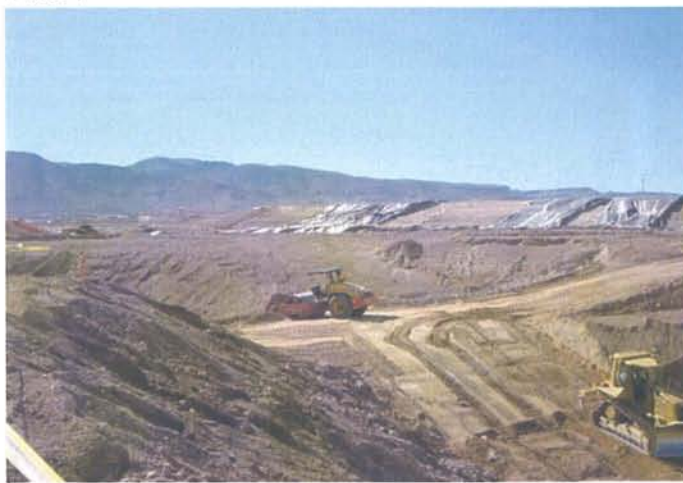
Photo 3

Monitor backfill operations in NW Basin/Phase IIIB trench.

CAMU: NW Basin/Phase IIIB, backfill.
