DAILY PRODUCTION & QUALITY CONTROL REPORT

Project No. Contract No.	Project Title Location	Day of Report	Report No.
6389	BRC Eastside Common Areas Soils Remediation	27-Feb-09	229

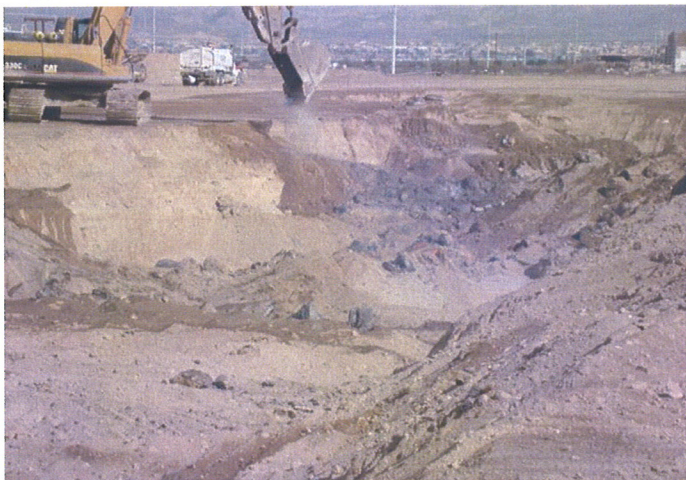
Photo 1

CAMU: Slit Trench, NW-2.

Inspections: Silt trenches, NW-2, Waste continues to be trash and paper products with soils. Also pyrophoric substances.

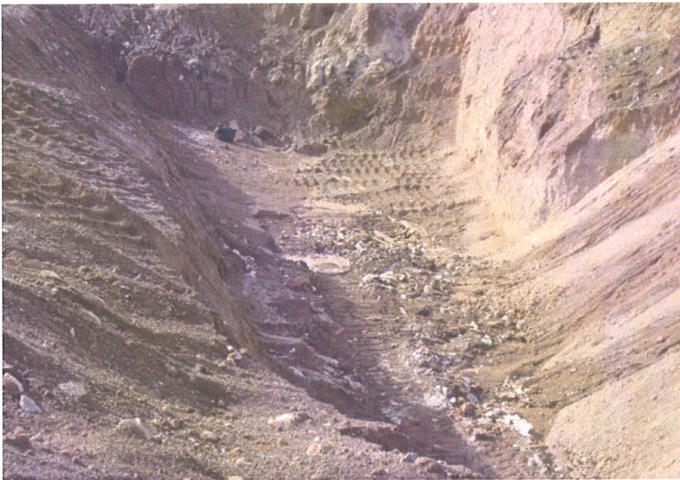
Photo 2

Camu: Slit trench, NW-3.

NW-3, Waste continued to be debris and with small amounts of paper. A green lime color waste continues. Pyrophoric substances activated periodically.

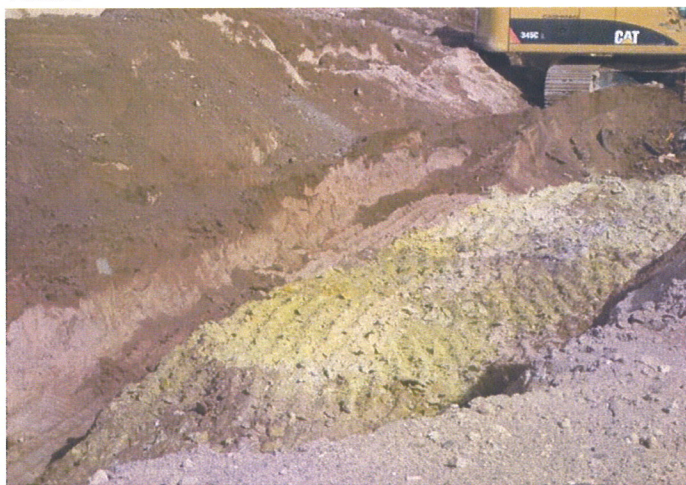
Photo 3

CAMU: Slit trench, NW-3.

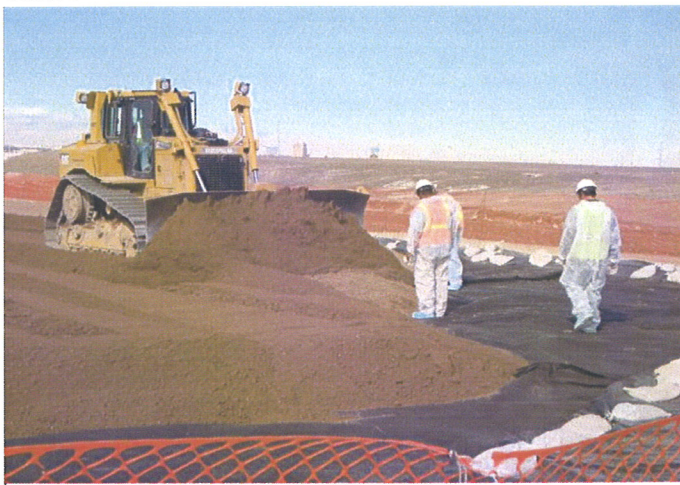
Photo 4

CAMU: Slit trench, NW-3.
