DAILY PRODUCTION & QUALITY CONTROL REPORT

Project No./Contract No.	Project Title / Location	Day of Report	Report No.
6389	BRC Eastside Common Areas Soils Remediation	20-Apr-09	281

DAILY PHOTO LOG

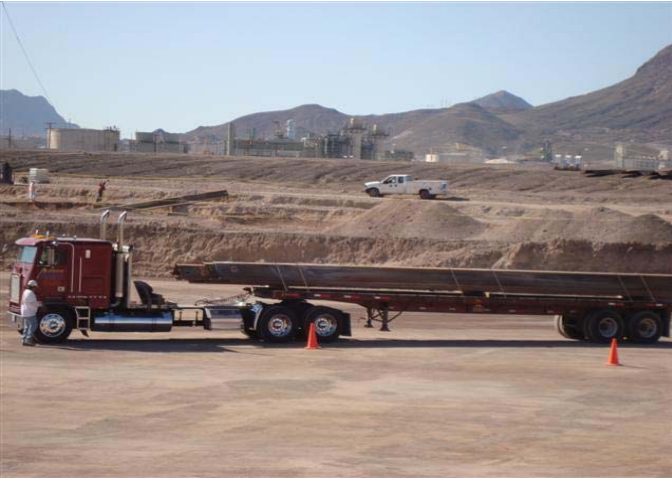
Photo 1

- Foundation Pile driving Co. continued removing sheet piling at SW-2/BMI South.

CAMU: Sheet Piling leaving site.

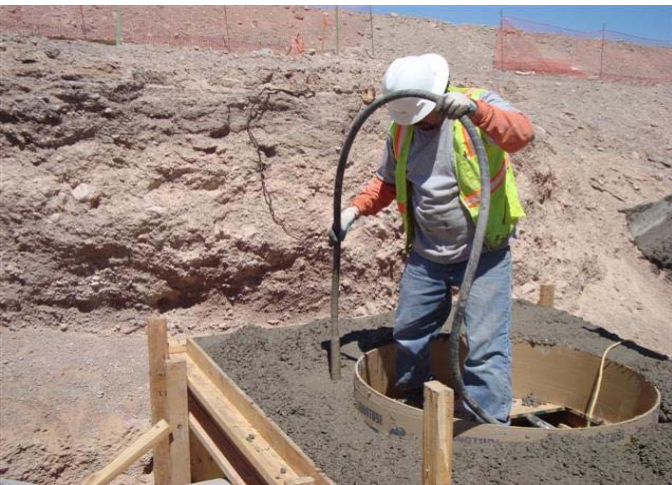
Photo 3

- Jensen poured concrete at MH # 4 of stormwater drainage system and formed MH's # 5, 6 & 7.

CAMU: Manhole # 4, Storm drainage system.

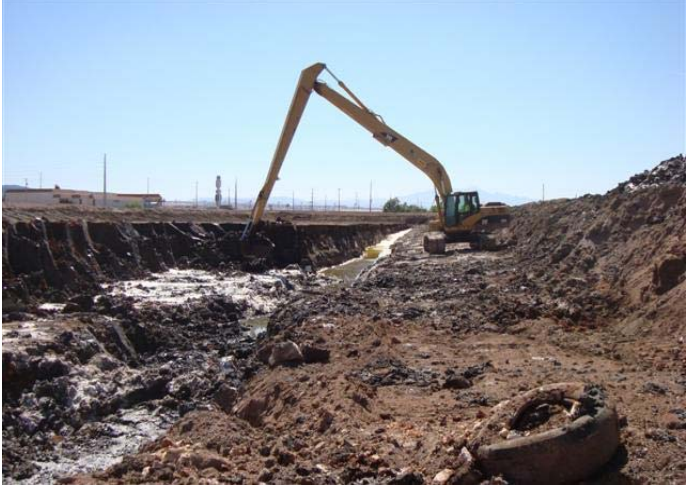
Photo 4

- Long stick excavator, casting wet material from SC-1 to south slope of SW-4.

Eastside: SC-1, removing wet material.
