DAILY PRODUCTION & QUALITY CONTROL REPORT

Project No./Contract No.	Project Title / Location	Day of Report	Report No.
6389	BRC Eastside Common Areas Soils Remediation	08-May-09	299

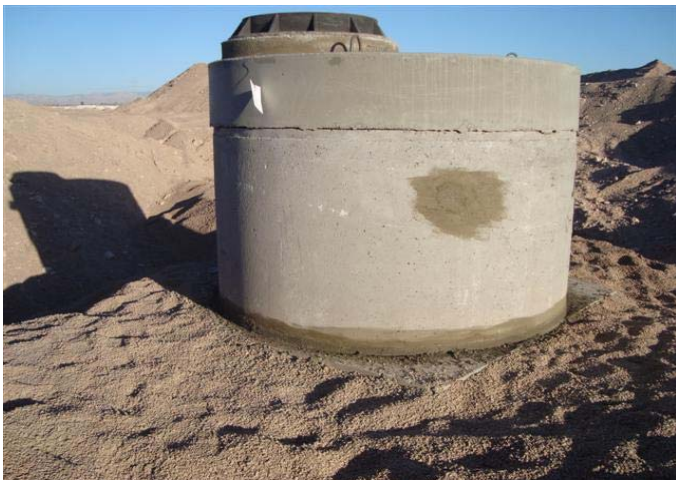
Photo 1

CAMU: Storm drain manhole.

- Jensen concrete contractor finished grouting storm drain manholes and covers. Entact backfilled partially.							
<u>Night Shift:</u>							
- Continued placing material in Phase II and IIIA.							
<u>Embankment</u>

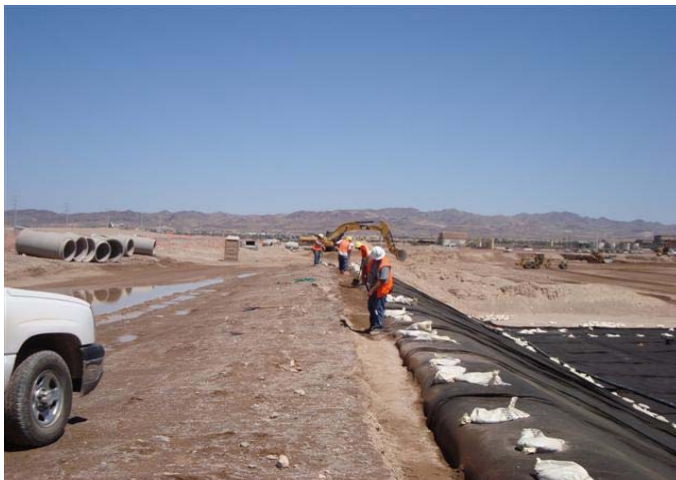
Photo 2

CAMU: Phase IIIB, anchor trench.

- Phase IIIB backfilling and compacting anchor trench. Testing performed by Geosyntec.							
- ESI Liner Crew installing geocomposite in Phase IIIB continued.

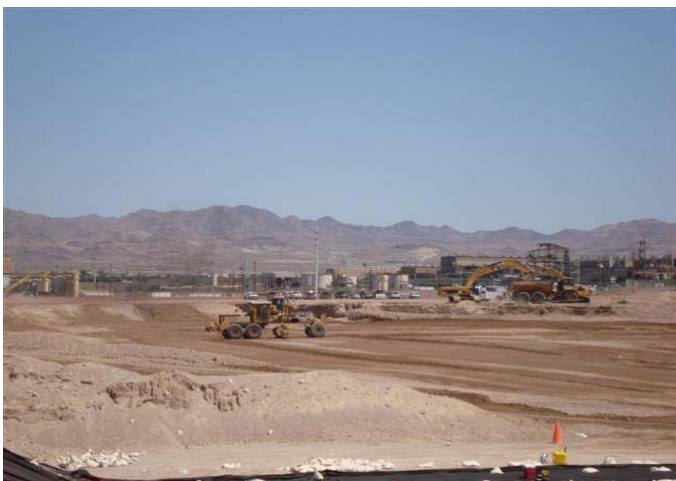
Photo 3

CAMU: Phase IV, grading.

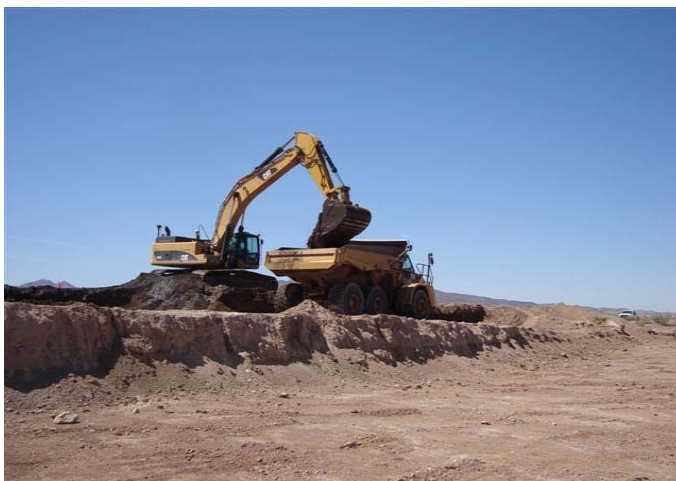
Photo 4

Eastside: 7A scrape, PUB haul rd.
