Basic Remediation Company

Restoration Advisory Committee  
Meeting

April 9, 2009

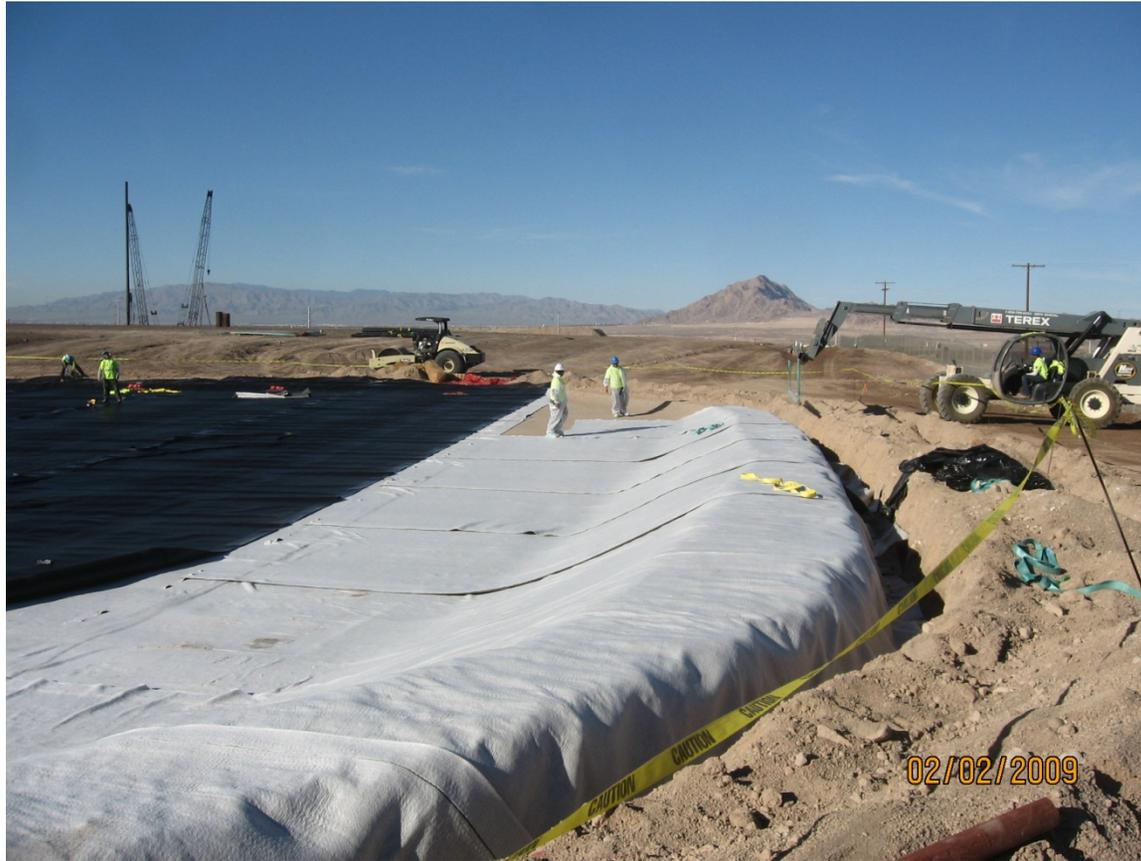
## CAMU IIIA - GCL Installation

Installation of geosynthetic clay liner (GCL) with staggered geomembrane deployment.

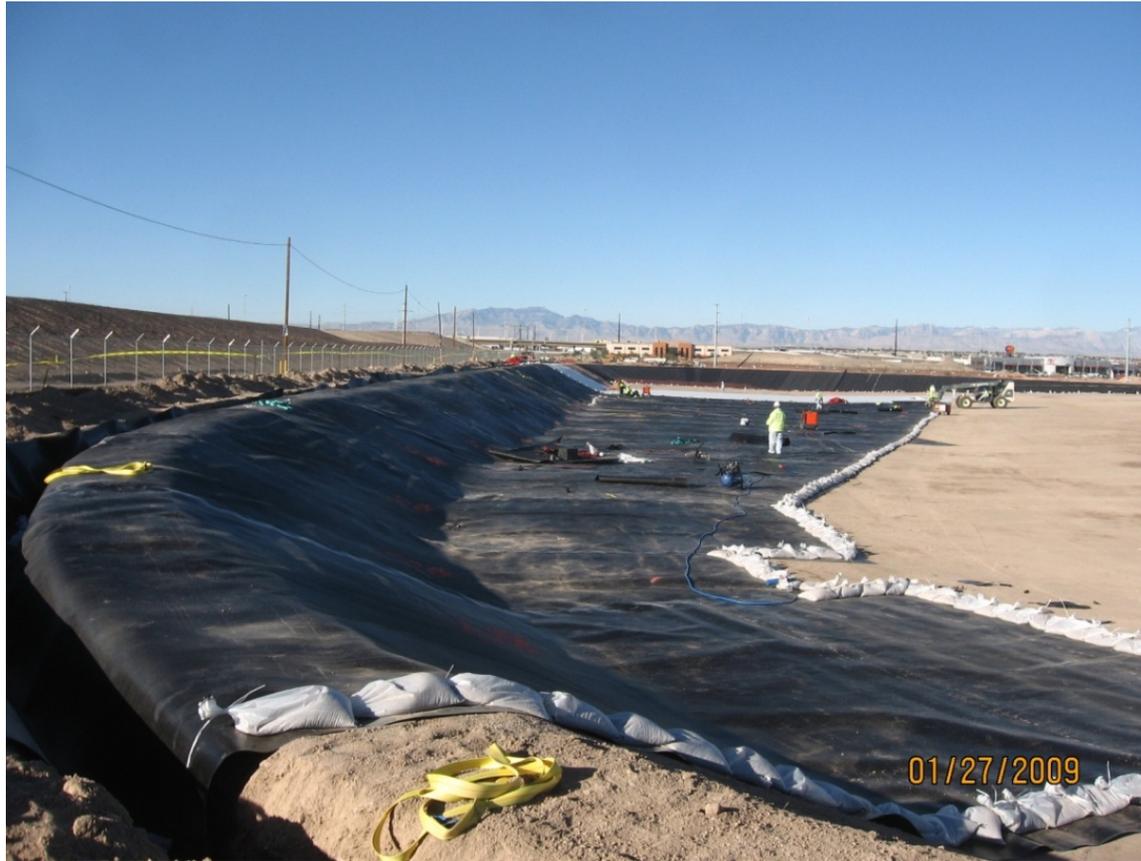
## **CAMU IIIA - Geomembrane Installation**

Geomembrane deployment with sandbags along edges to prevent stormwater and dust control water from hydrating underlying GCL

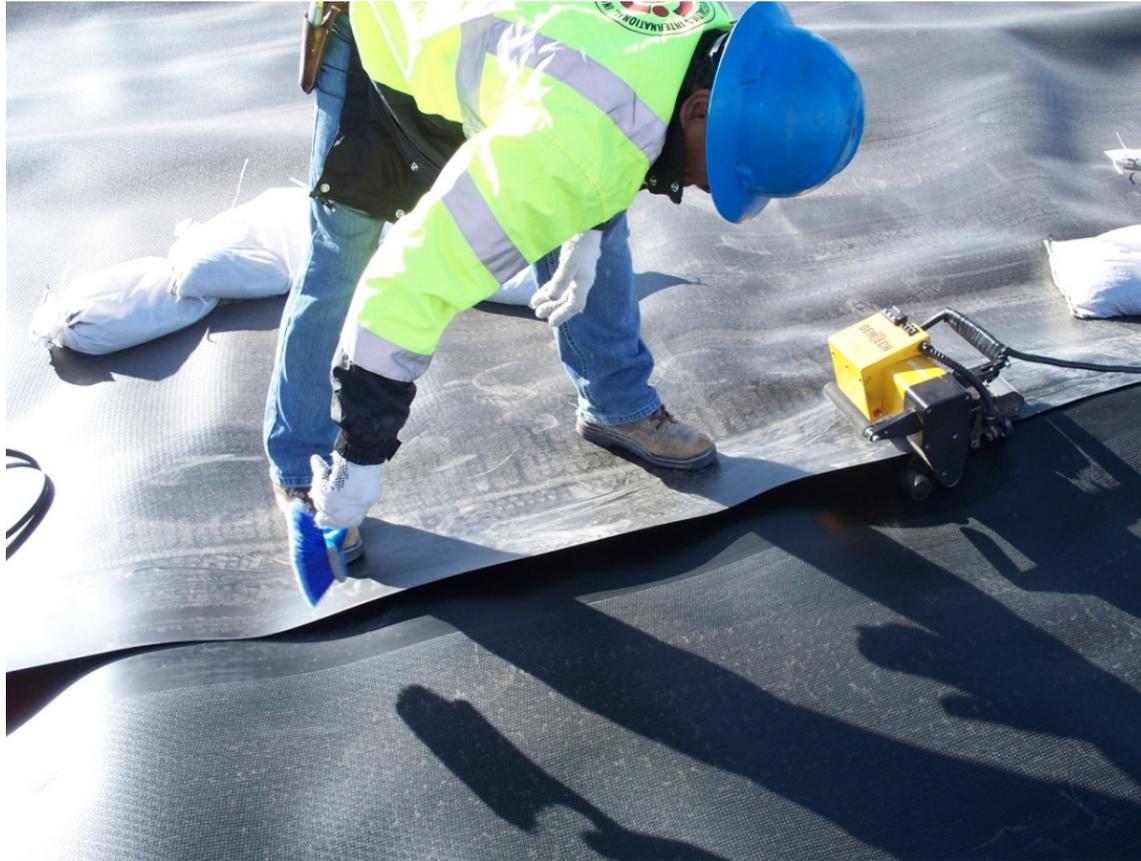
## **CAMU IIIA - Geomembrane Seaming**

ESI personnel sweep away dust and debris from geomembrane overlap as welding machine seams panels.

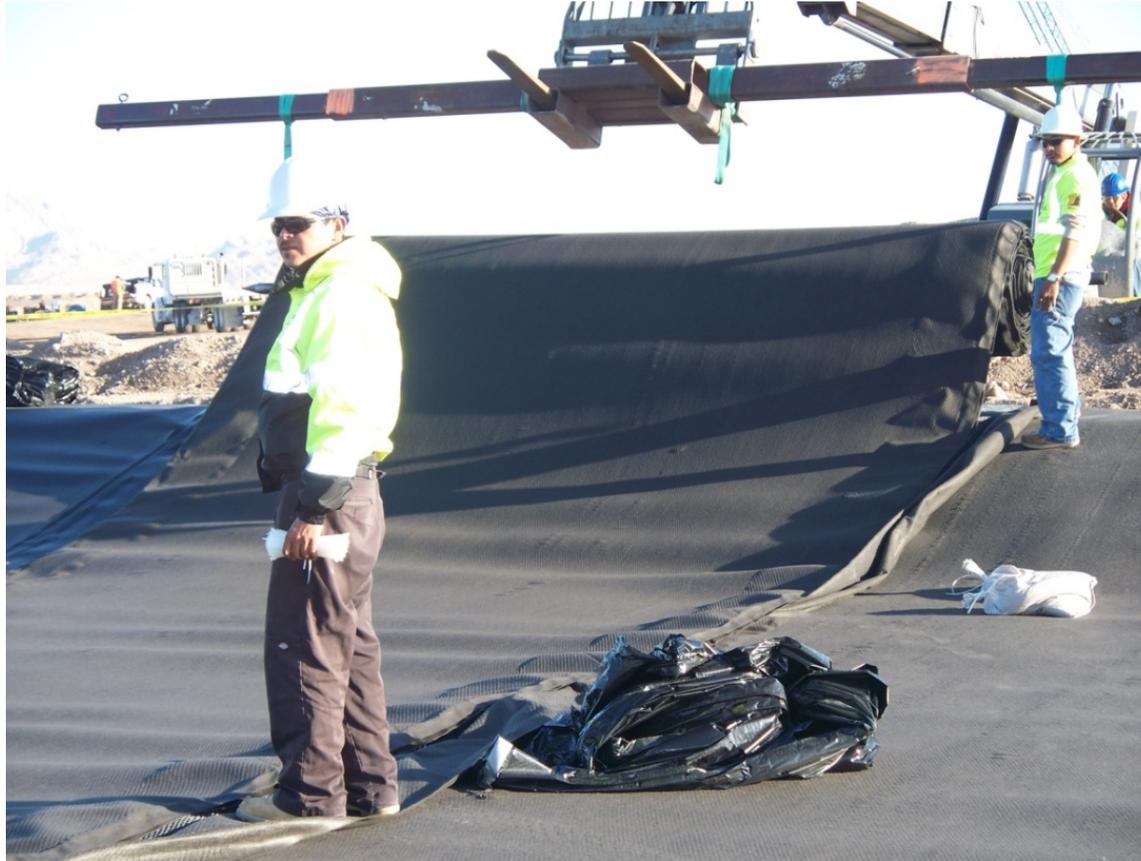
## **CAMU IIIA - Geocomposite Installation**

Spreader bar used to raise geocomposite roll.

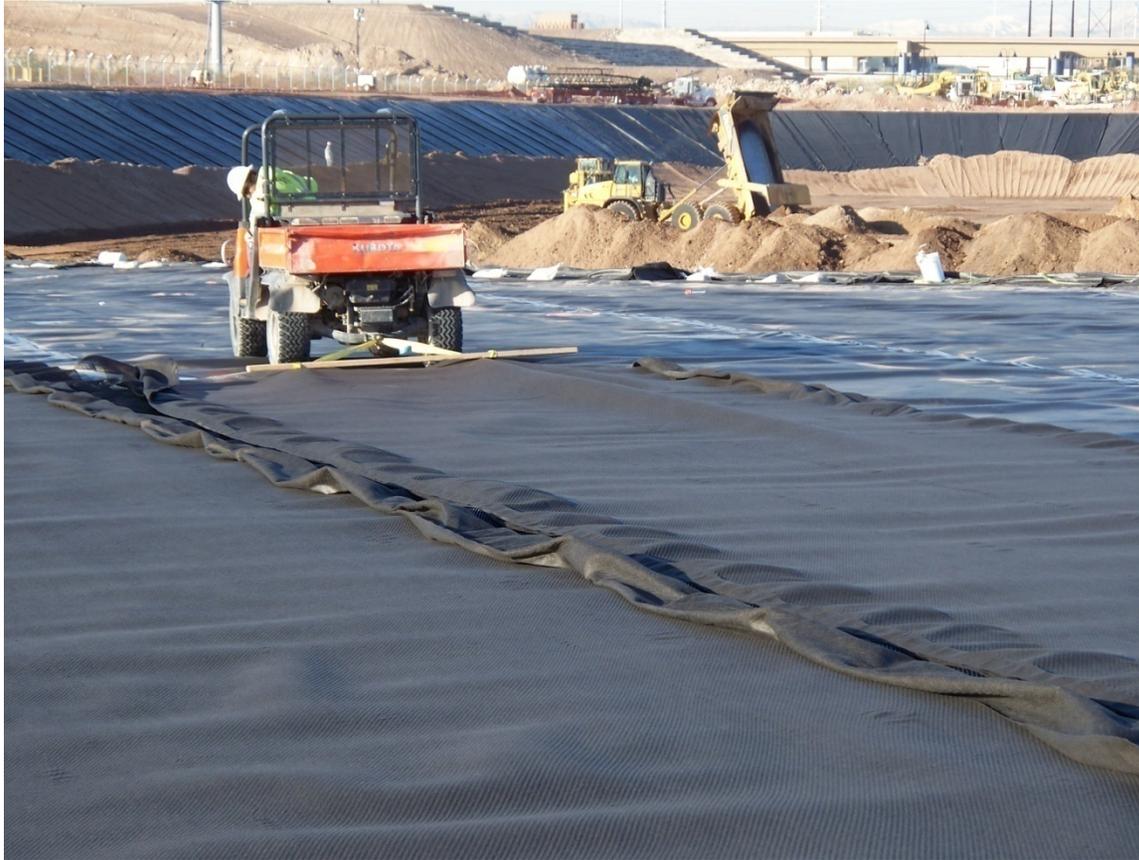
## **CAMU IIIA - Geocomposite Installation**

Low pressure equipment is used to pull geocomposite from spreader bar above geomembrane.

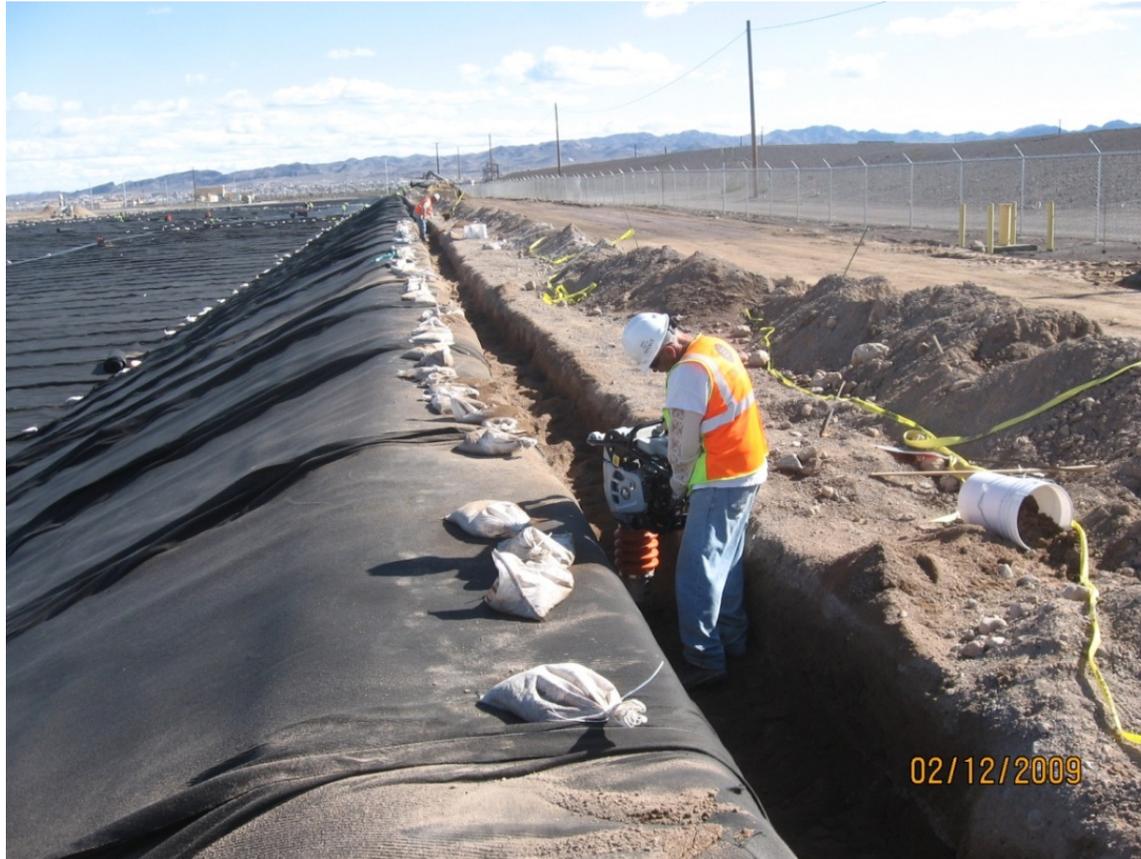
## **CAMU IIIA - Anchor Trench Backfill**

Placement and compaction of anchor trench backfill to secure liner system.

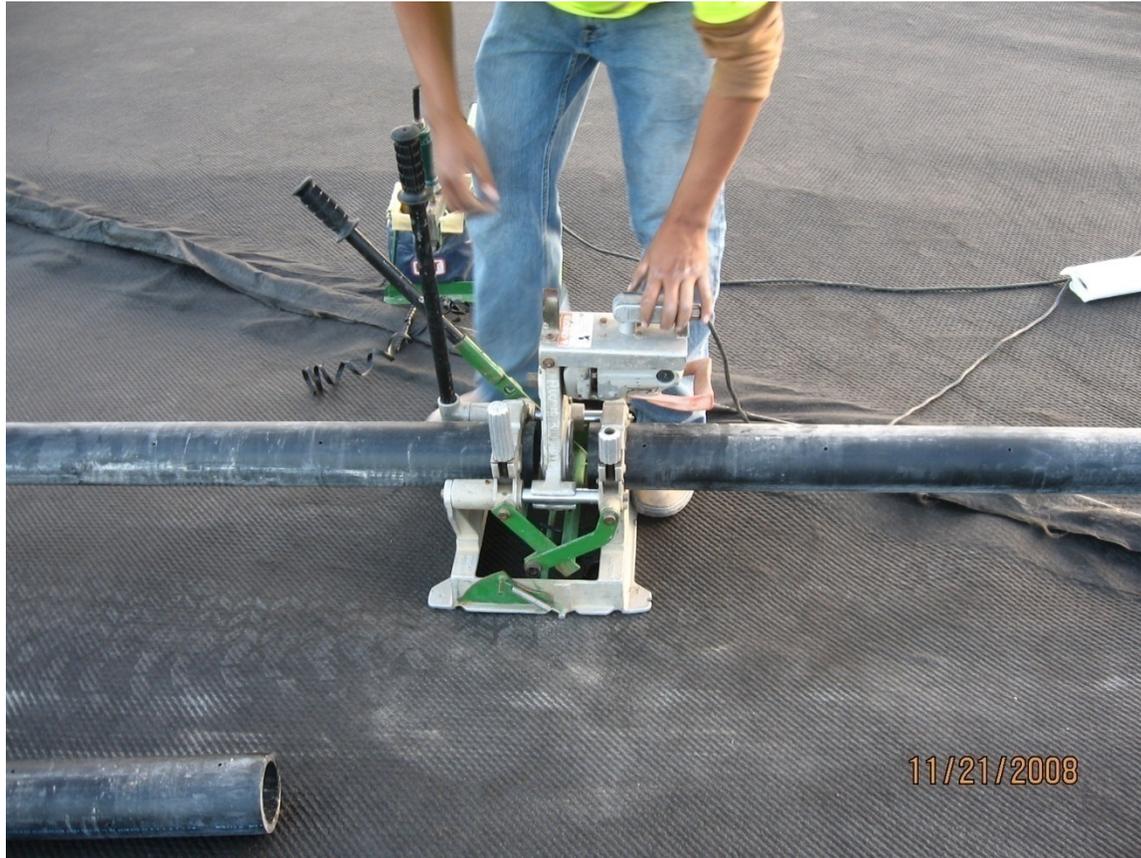
## **CAMU IIIA - HDPE Welding**

Butt-fusion welding of HDPE leachate collection pipes.

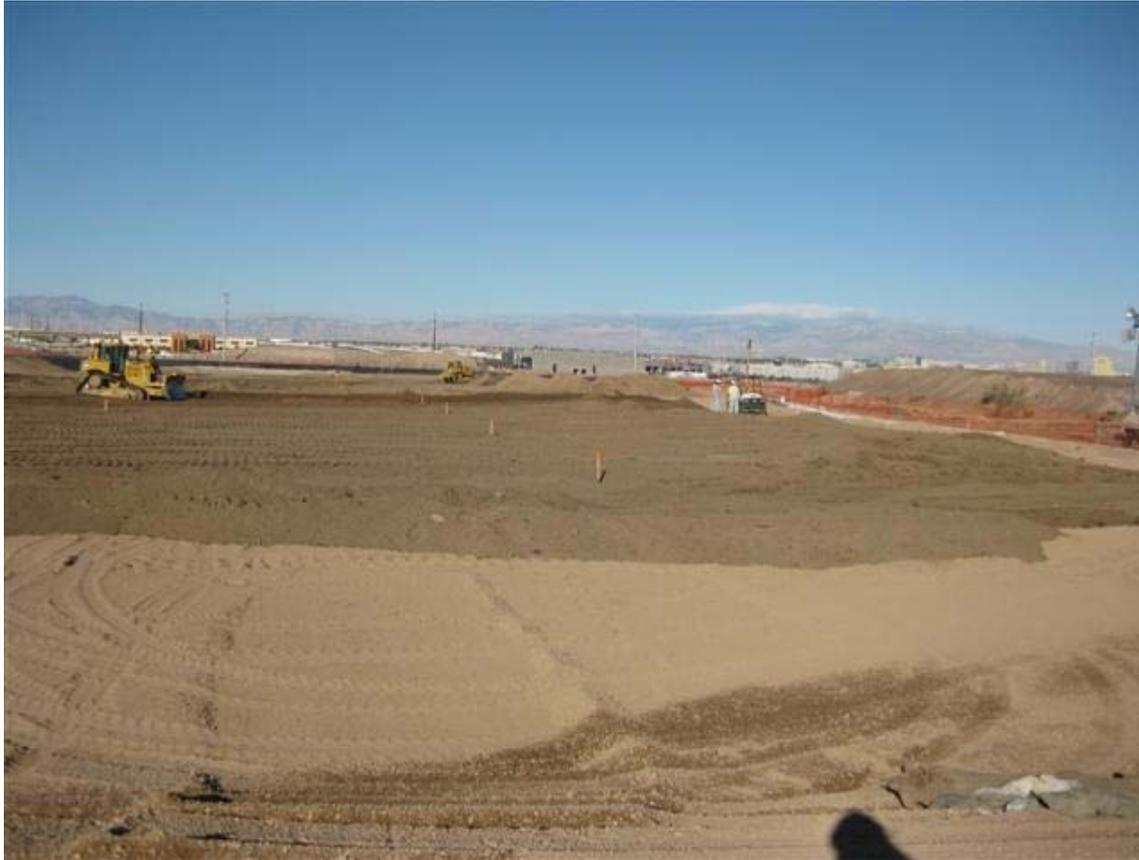
## **CAMU IIIA - Operations Layer Placement**

Placement of two feet of operations layer material to protect geosynthetics during waste placement.
