Basic Remediation Company 875 West Warm Springs Road Henderson, Nevada 89011

DAILY PRODUCTION & QUALITY CONTROL REPORT

Project No./Contract No.	Project Title / Location	Day of Report	Report No
6389	BRC Eastside Common Areas Soils Remediation	18-Jul-08	25
		10-001-00	25

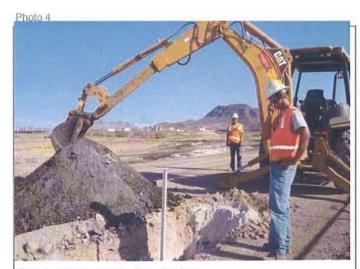
Pothole, West haul rd, Excavated to 10'. Top layer approx: 18" of clean. Middle layer: approx: 2' of white material

Remaining layer: 6' black material and debri, still evident.

Pothole with measuring stick at 10 feet.

3. Cap haul rds 12" with clean soils. where discolored soils may continue below grade.
