DAILY PRODUCTION & QUALITY CONTROL REPORT

Project No./Contract No.	Project Title / Location	Day of Report	Report No.
6389	BRC Eastside Common Areas Soils Remediation	04-Aug-08	39

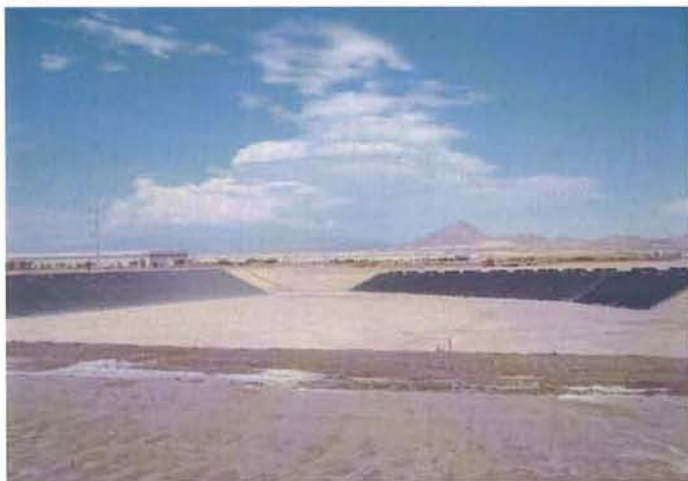
Photo 1

CAMU, Phase 1, East slope liner installed.

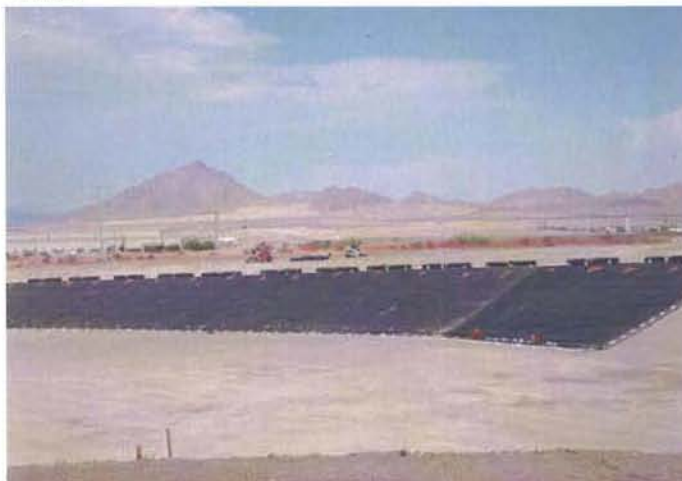
Photo 2

CAMU, Phase 1, Liner Crew Deploying liner on East Slope.

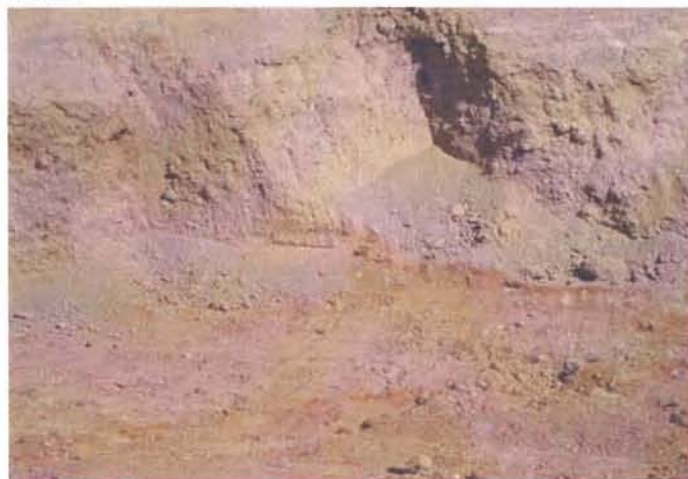
Photo 3

- SW-8, 345 excavator remediating additional discolored soils below liner. Monitored by Construction Manager. (97) loads = (2,134) cy, to beta - ditch stockpile. Two spots excavated an additional 10' total, still discolored.

Eastside, SW-8. Additional discolored soils excavated to 5' below liner.

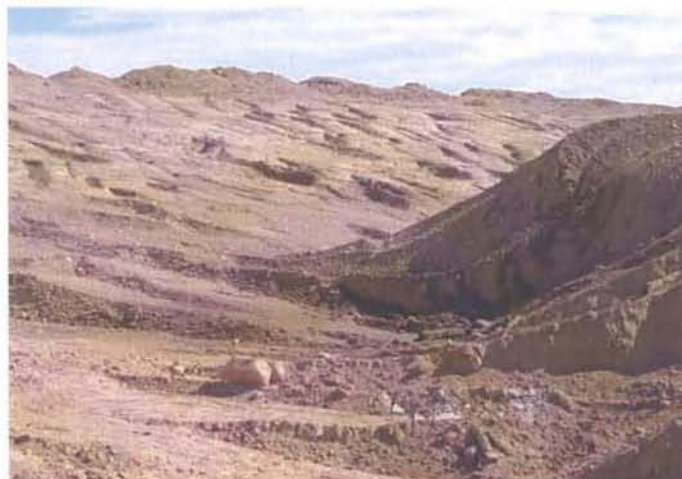
Photo 4

Eastside, SW-8. Remediation below liner. Two areas remain discolored after 10' excavation below liner.

Eastside, SW-8 discolored soils.
