DAILY PRODUCTION & QUALITY CONTROL REPORT

Project No./Contract No.	Project Title / Location	Day of Report	Report No.
6389	BRC Eastside Common Areas Soils Remediation	05-Aug-08	40

Eastside Mixing and Drying Activity:

CAMU Activity:

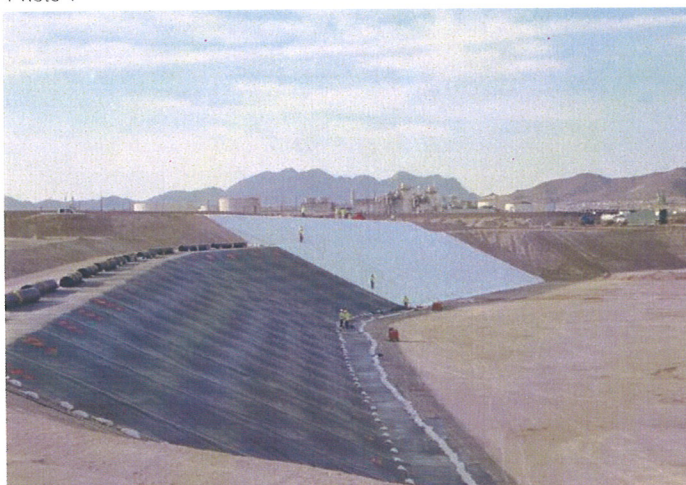
Photo 1

CAMU, Phase 1, East slope liner installation.

Inspected and documented, Phase 1 Liner Installation, on East slope..

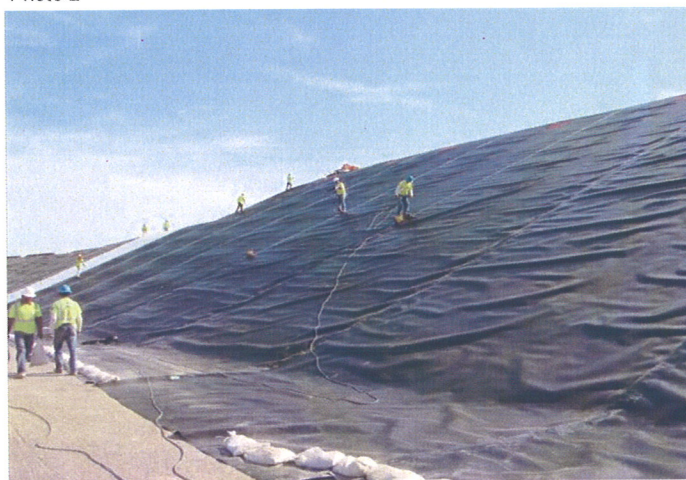
Photo 2

CAMU, Phase 1, Liner Crew Deploying liner on East Slope.

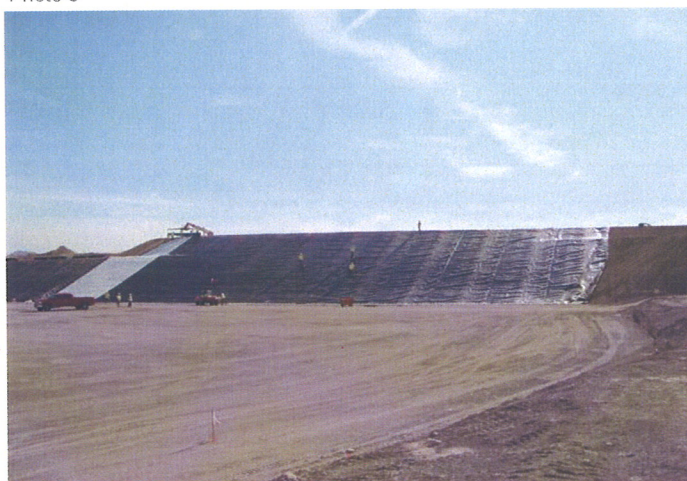
Photo 3

CAMU, Phase 1, End of East slope liner installation.

Liner Crew finished installation on east slope, & top of berm. Began liner on floor before shut down due to temperature.
