DAILY PRODUCTION & QUALITY CONTROL REPORT

Project No./Contract No.	Project Title / Location	Day of Report	Report No.
6389	BRC Eastside Common Areas Soils Remediation	11-Aug-08	45

DAILY PHOTO LOG

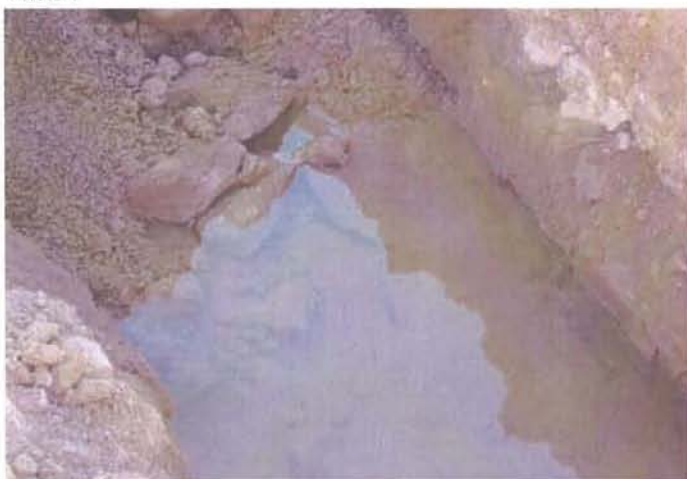
Photo 1

Phase 2, Entact excavated a sump 4.5" deep on 8-9-08. On 8-11-08 there was water on the bottom of trench.

CAMU, Phase 2, trench bottom of sump, Monday morning.

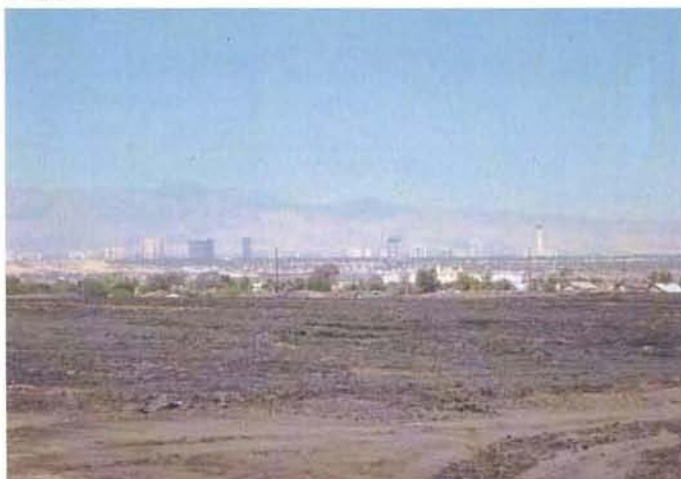
Photo 2

Eastside, disked wet material drying.

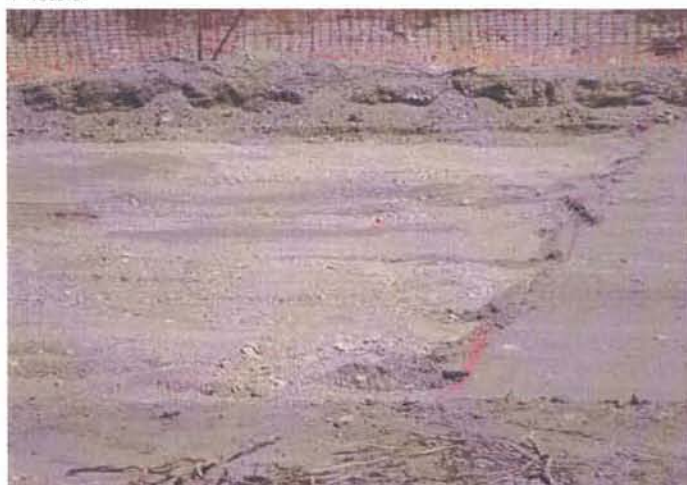
Photo 3

Eastside, Beginning of Sewer Realignment remediation scraping.

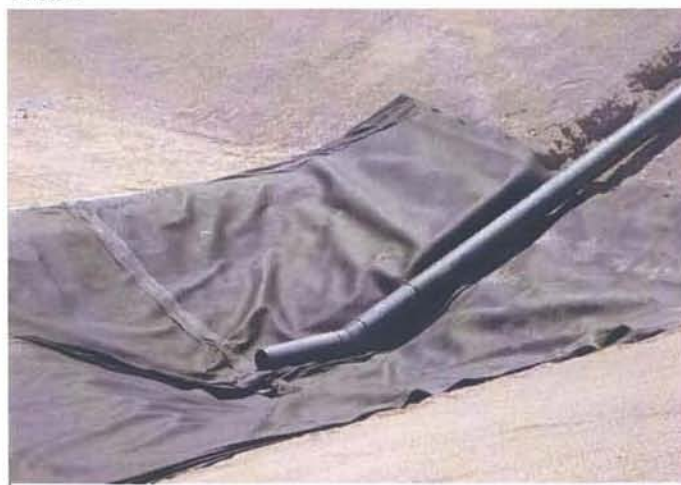
Photo 4

- Phase 1 liner installed sump rock and liner. Also 12" HDPE Pipe 86 lf, up slope. QC performed.
- Phase 1 GCL placed: 400 sf daily, 306,567 sf cumulative
- Phase 1 Geomembrane: 400 sf daily, 328,858 sf cumulative
- Phase 1 Geocomposite: 0 sf daily, 0 sf cumulative
- Phase 1 Geotextile: 0 sf daily, 0 sf cumulative

CAMU, Phase 1 Sump partially built..
