DAILY PRODUCTION & QUALITY CONTROL REPORT

Project No./Contract No.	Project Title / Location	Day of Report	Report No.
6389	BRC Eastside Common Areas Soils Remediation	15-Sep-08	76

DAILY PHOTO LOG

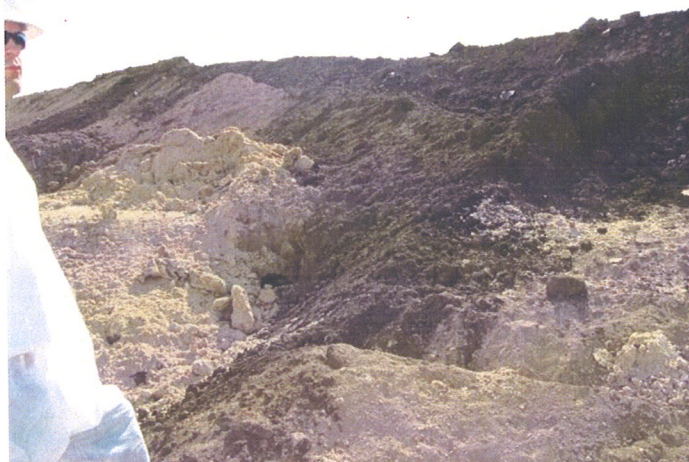
Photo 1

Eastside: Soils chosen for one pad.

Two test pads constructed on eastside with contaminated material. 50'X50'. 12" thick.

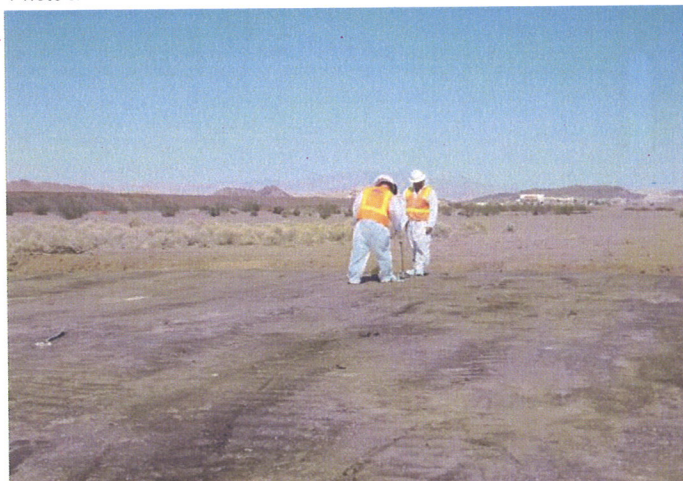
Photo 2

Eastside, Geosyntec performing compaction testing on test pads..

Observed two test pads built on eastside. Performed compaction testing and observed loaded haul truck on pads for rutting. Met spec.

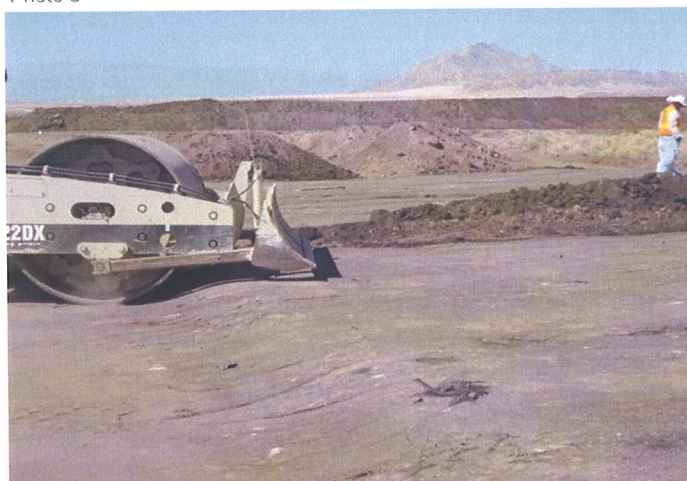
Photo 3

Eastside: Roller used to provide compaction.

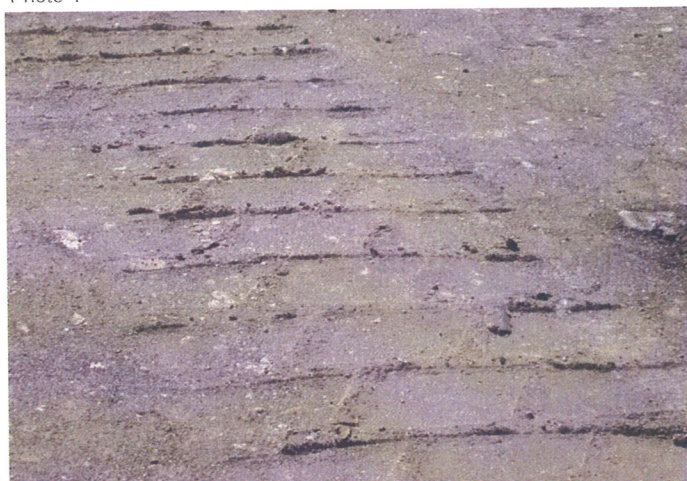
Photo 4

Eastside: Rutting was minor after 40 ton loaded dump truck backed on test pad.
