## Memorandum

Subject: Leachate and Vadose Zone Sump Evaluation  
Basic Remediation Company  
Corrective Action Management Unit  
Geosyntec Project: SC0313

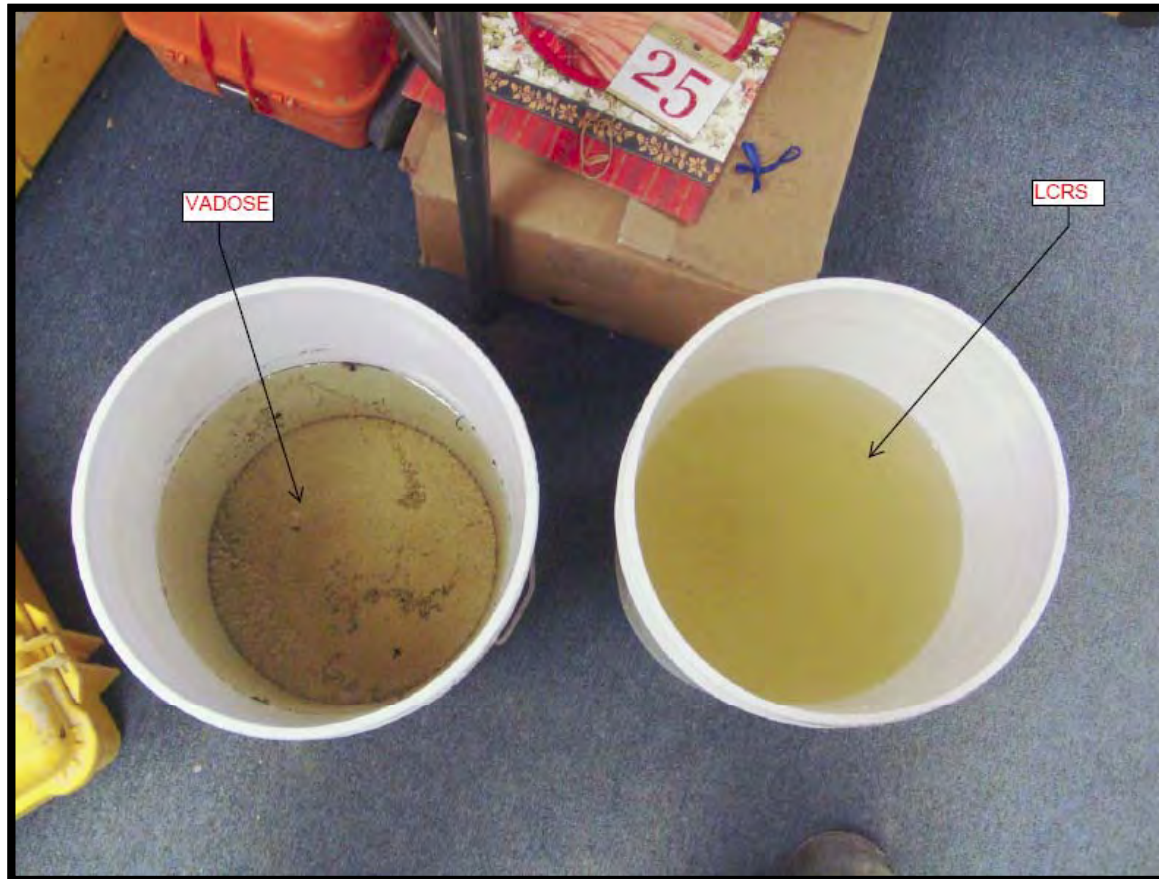
## Attachment 3

## **Vadose Zone Liquid versus LCRS Leachate**

Vadose Zone Liquid (left): clear, some solids

LCRS Leachate (right): murky, yellow, unknown solids

the liquids collected from the LCRS and vadose zone sumps was different as the LCRS leachate is murky and brown/tan in color while vadose zone liquid is clear (Attachment 3). Results of testing indicated the vadose zone liquid was impacted with constituents similar to the LCRS leachate, but at diluted concentrations from the LCRS leachate, with the exception that several of the organo-chlorine pesticides that were found in the LCRS sump leachate were not found in the vadose zone sump liquid. In addition, the vadose zone liquid analytical data is impacted with similar chemicals and concentrations as the site groundwater.

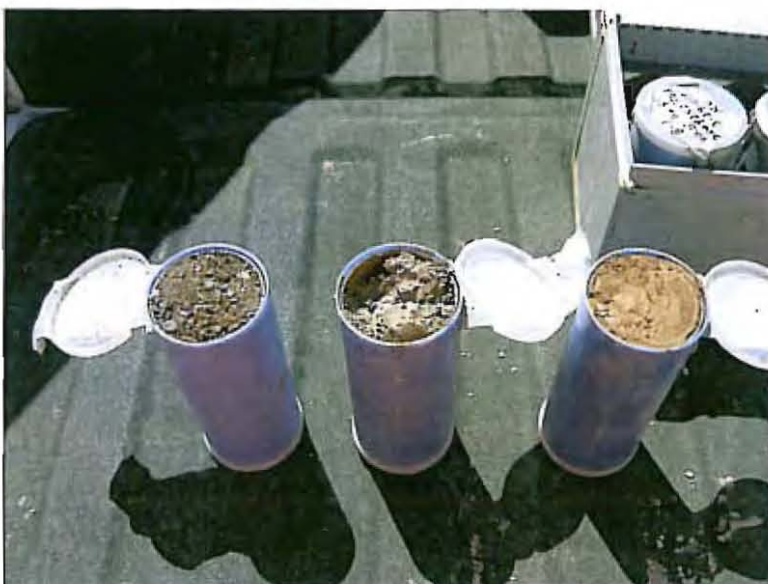
6. Transition to wet MCF: Dark gray and moist, gray and wet, brown and moist.

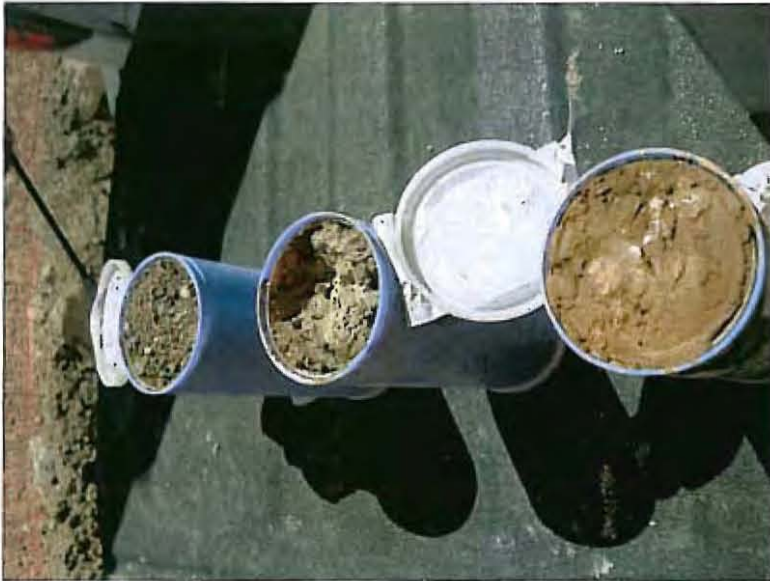
7. Transition to wet MCF: Dark gray and moist, gray and wet, brown and moist.

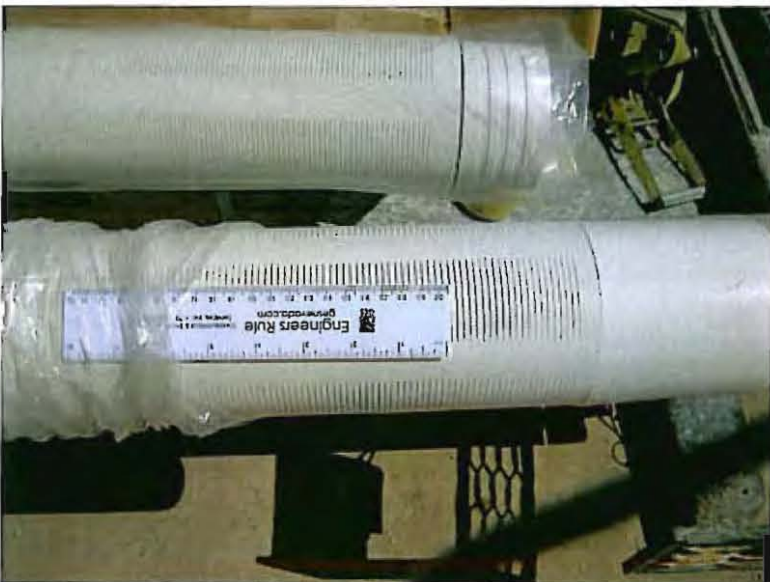
8. Close-up of screen with scale.

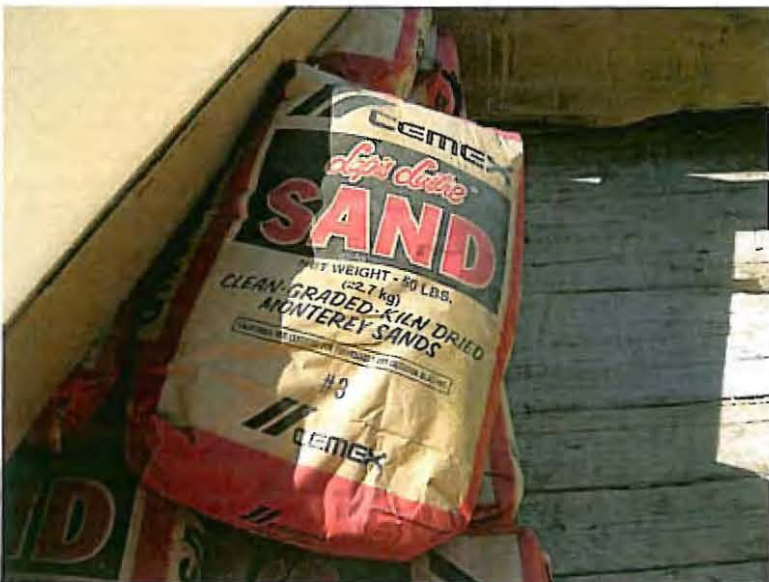
12. #3 sand used for sand pack.

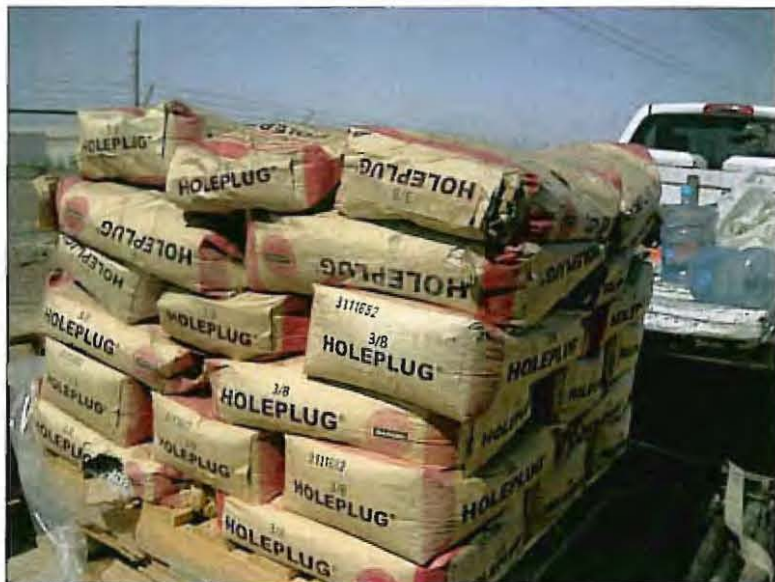
13. 3/8" bentonite used for seal.

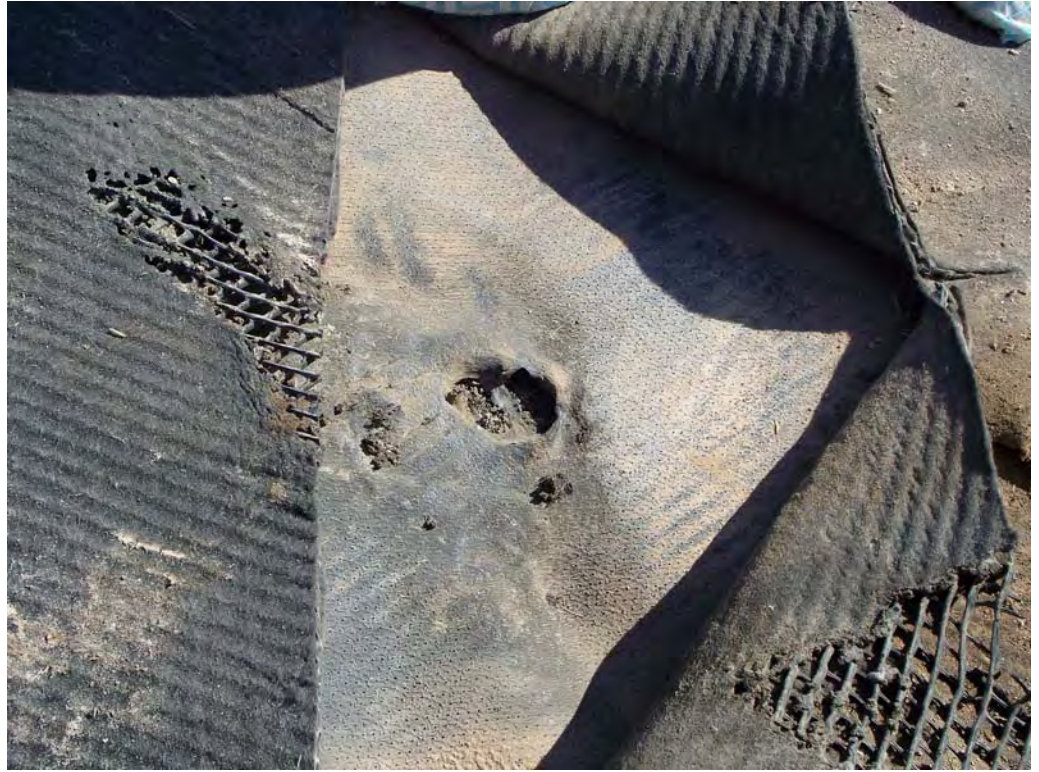
Description:  
Burn hole on  
Phase I side  
slope from  
generator.  
Damaged  
geocomposite  
and  
geomembrane  
shown.

After the 25 August 2008 rain event, a generator used to power the pump to remove the leachate from the LCRS sump burned a hole through the geomembrane and scorched the top geotextile component of the underlying GCL at an approximate elevation of 1726 ft MSL. The hole was temporarily closed with a patch and duct taped. The liner installer, ESI, arrived onsite 6 September 2008 to make the repair (repair number R-177). The repair was cut open and a small portion of the top geotextile of the GCL was witnessed to be "degraded" by the heat but not hydrated (Attachment 6). A new piece of GCL was installed, as per the specification, over the affected area. The repair to the geomembrane was completed and vacuum tested and passed. The geocomposite was also repaired per the specifications.

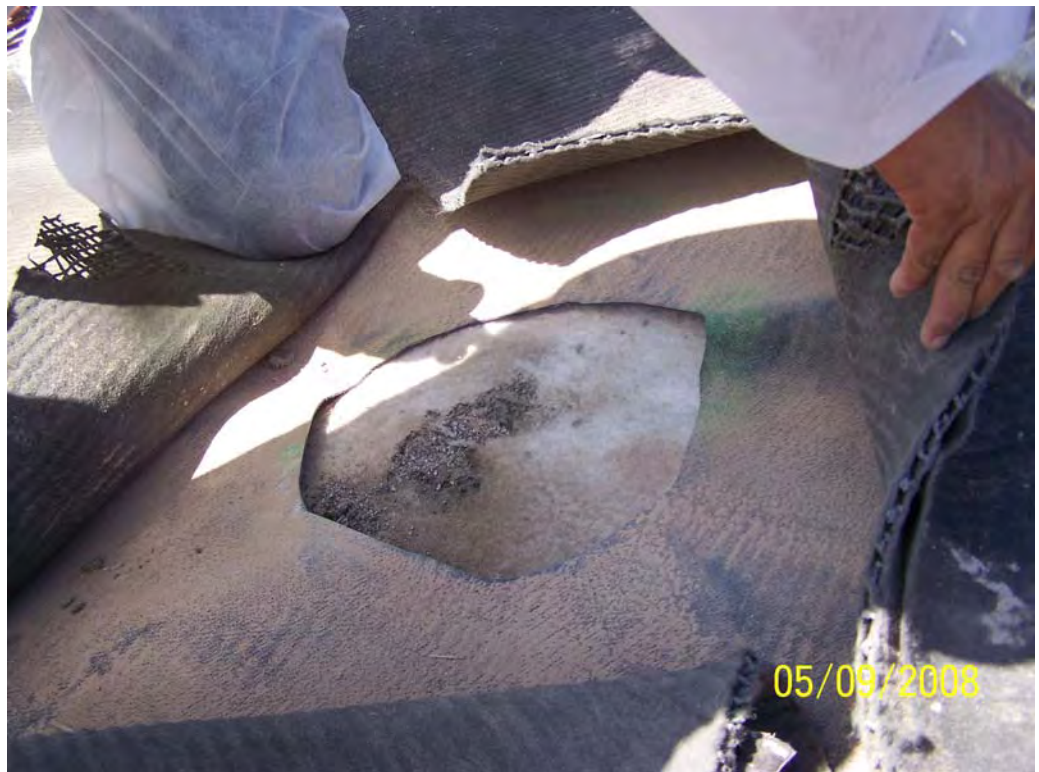
Description:  
Burn hole on  
Phase I side  
slope from  
generator.  
Damaged  
GCL shown.  
Note granular  
bentonite  
indicating  
GCL is non-  
hydrated.

of the hole appear to indicate that the GCL was not hydrated prior to making the repair (Attachment 6). Therefore, it does not appear leachate drained through the hole during pumping. As documented in the Phase I as-built drawings (Geosyntec, 2008b), based on the elevation of the repair, 1726 ft MSL, the elevation of the LCRS sump liner, 1720.65ft MSL, and the maximum estimated depth of leachate, 3.45 ft, the maximum elevation of the leachate was approximately 1724.1 ft MSL. Therefore, it is unlikely leachate entered the vadose zone sump through the hole caused by the generator.

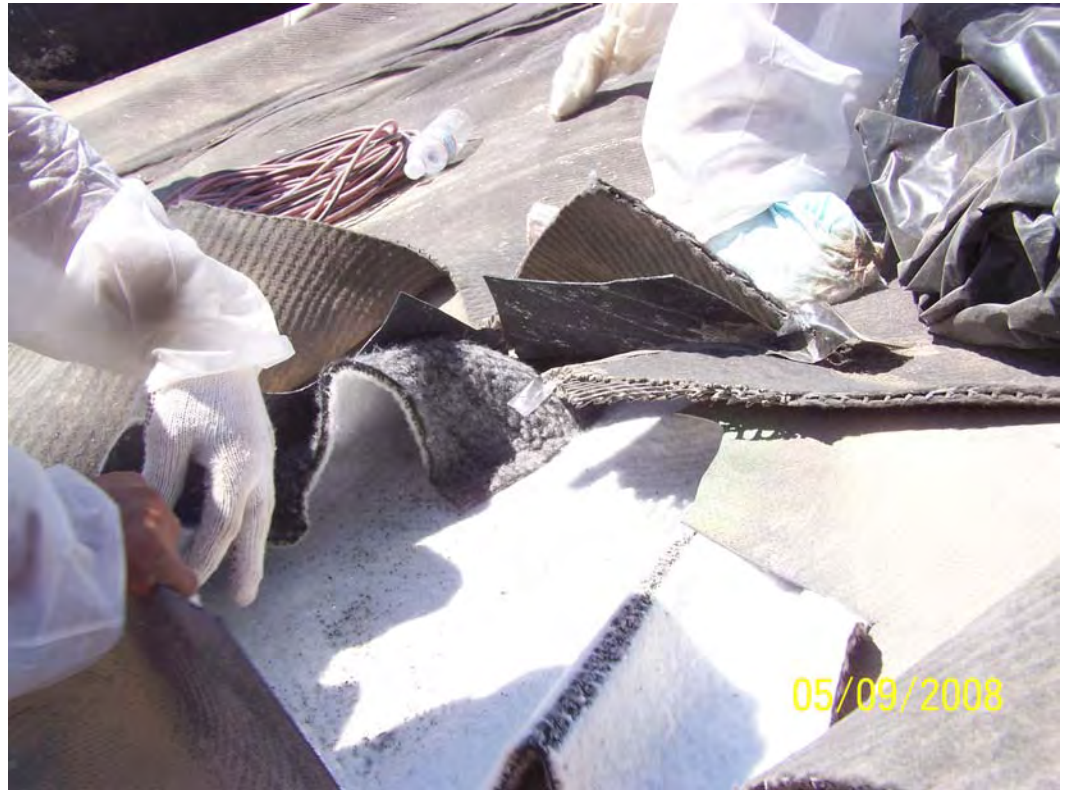
Description:  
Repair to  
GCL in  
accordance  
with  
Technical  
Specifications
