DAILY PRODUCTION & QUALITY CONTROL REPORT

Project No./Contract No.	Project Title / Location	Day of Report	Report No.
6389	BRC Eastside Common Areas Soils Remediation	24-Jul-08	30

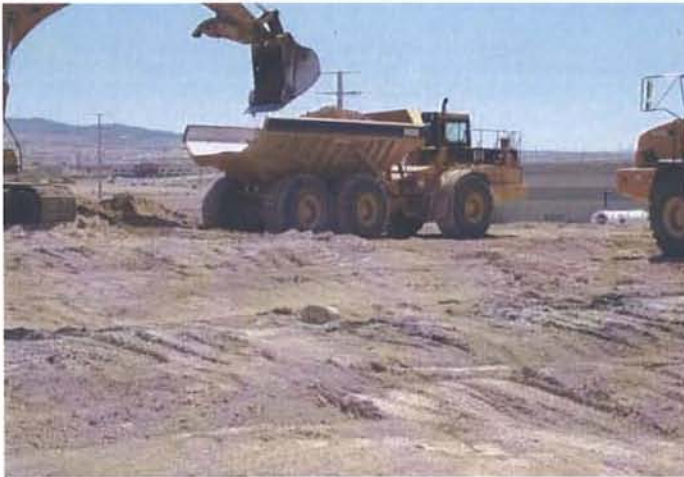
Photo 1

CAMU, 200,000 yd stockpile. removing discolored soils.

Inspected remediation work on 200,000 yd stockpile. Overall good. Marked several small pockets to remove, 7-25-08.

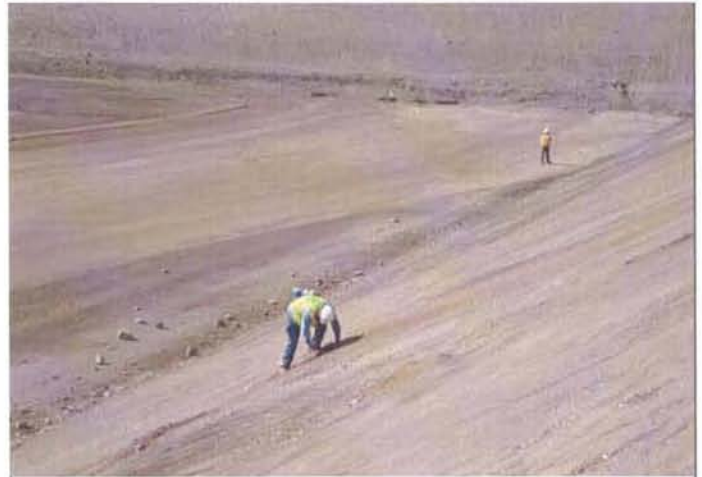
Photo 2

CAMU, Phase 1, West slope. Preparation.

Phase 1, west slope subgrade inspection, failed. In model area. Has greatly improved, needs little more work.

Results: Model area was greatly improved but does not meet requirements. Will reschedule when ready.

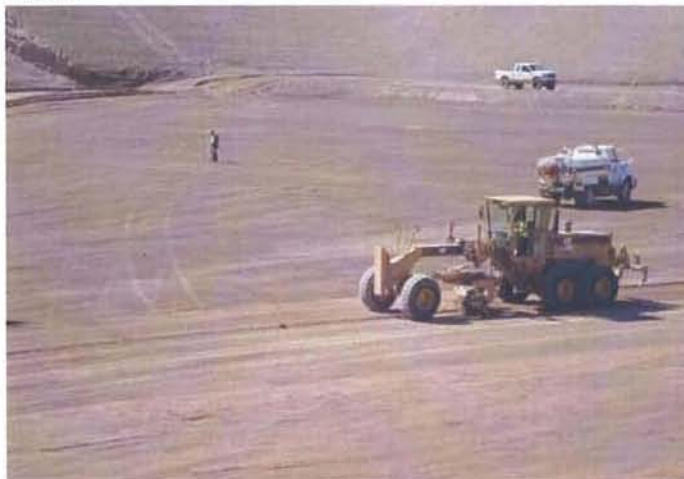
Photo 3

CAMU, Phase 1, Floor grading.

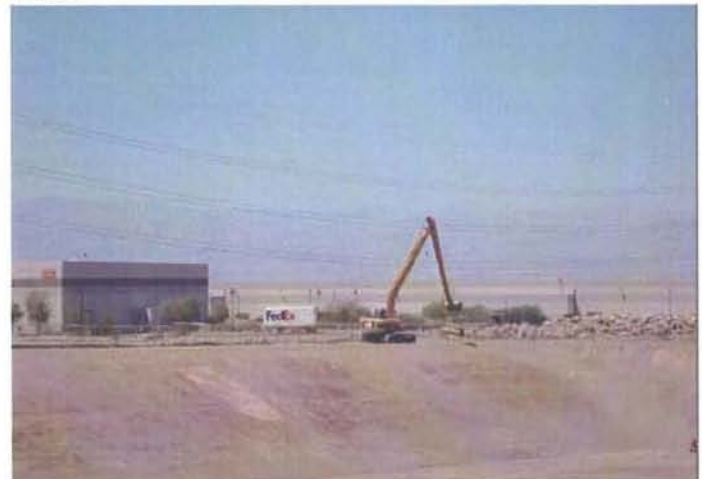
Photo 4

CAMU, Phase 1, West Slope. Long stick excavator with roller attachment.
